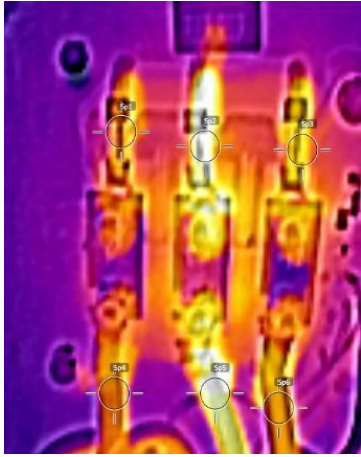
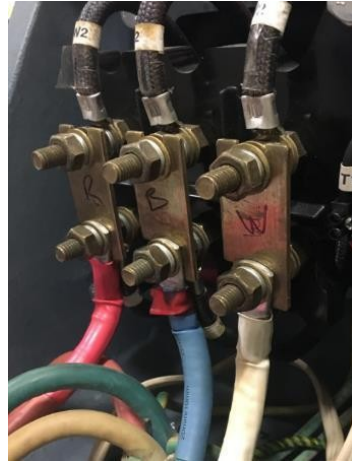
Blue Phase Loose top & bottom. Poor Assembly

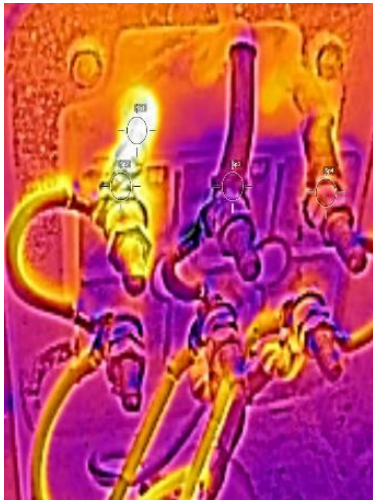
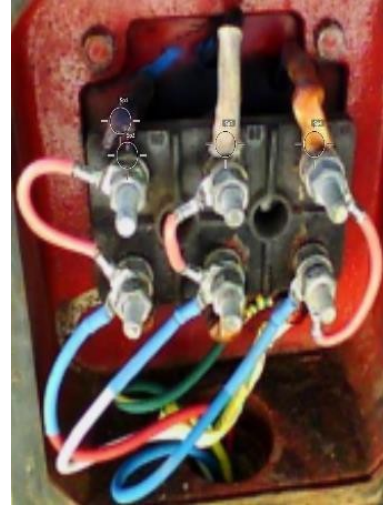
Poor crimp and termination

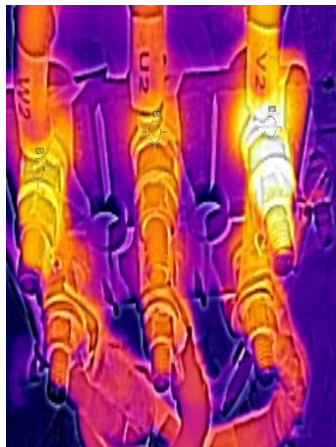
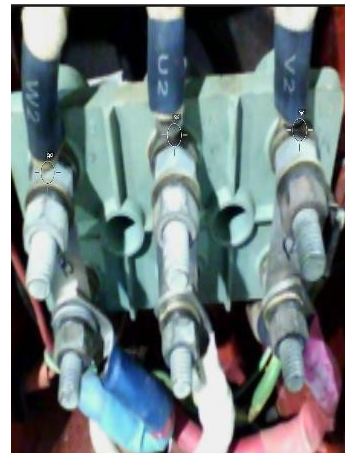
Loose bottom nut

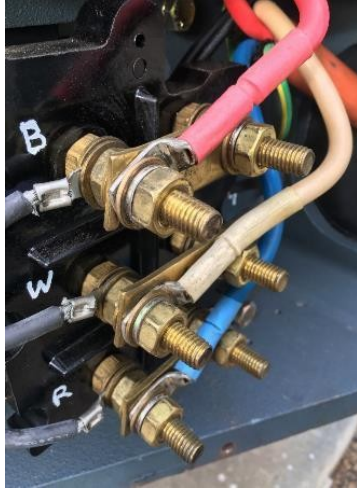
Current Path has high resistance

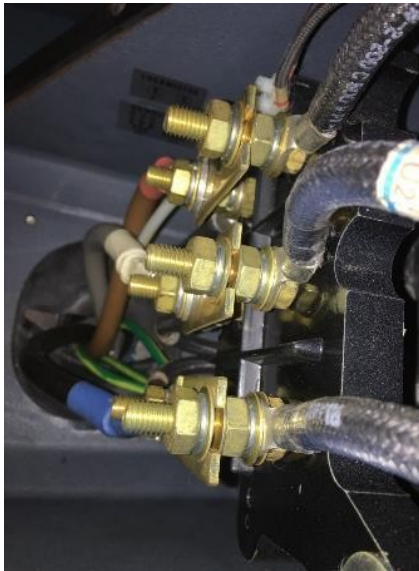
Poor assembly

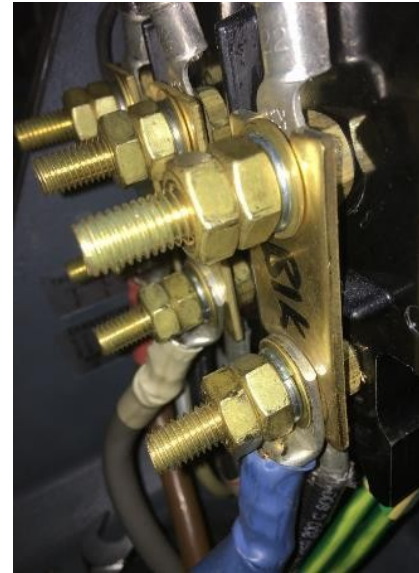
Supply, Delta Links and Motor lugs all together

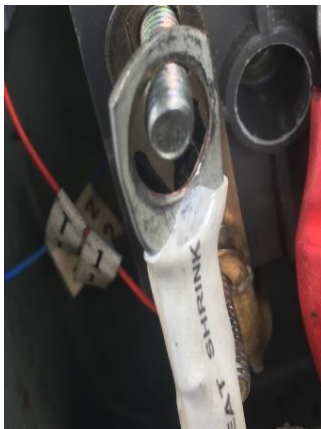
Lug too big poor current path, Heat Shrink Sandwich

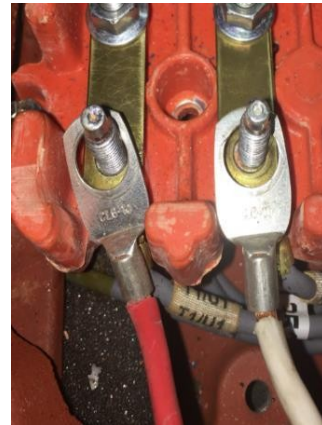
Poor lug selection

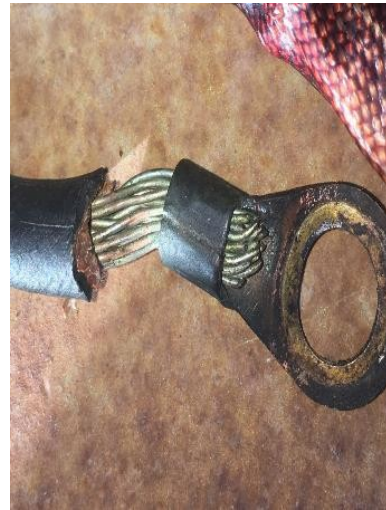
Poor crimp, and exposed conductor. Lug Size

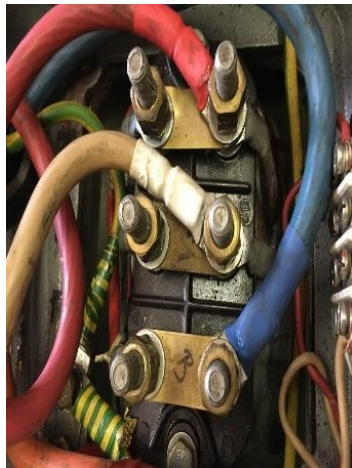
Supply leads touching conductive paths in multiple areas. Red delta link short to earth, too

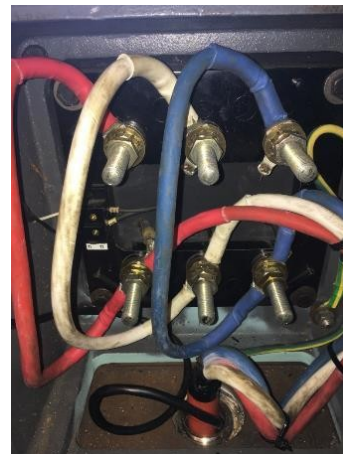
close to mounting bolt.VSD tripped

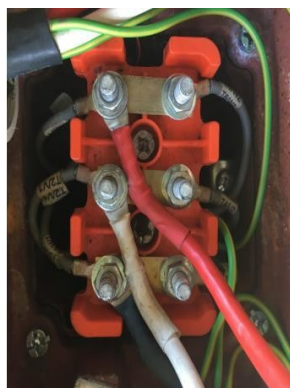
Red supply shorted to White phase

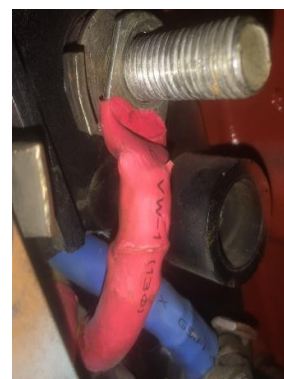
Heat Shrink Sandwich

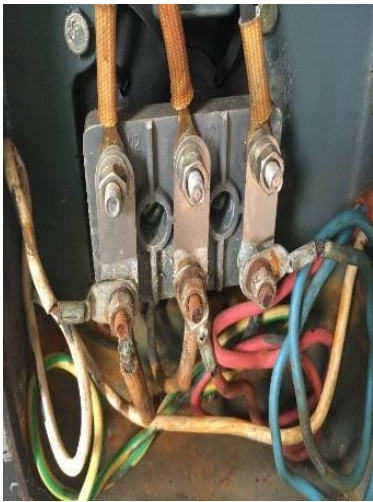
Corrosion High Resistive termination

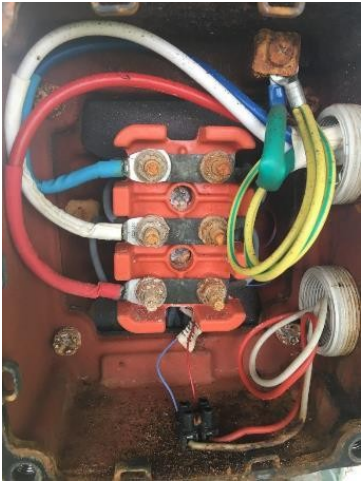
Corrosion, Poor Earth Termination

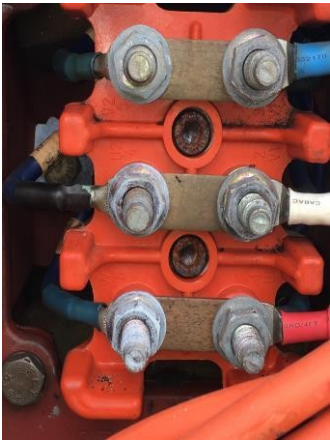
High Resistive crimp White Phase

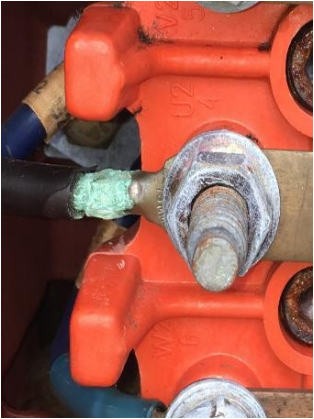
Removed Insulation to find Corrosion

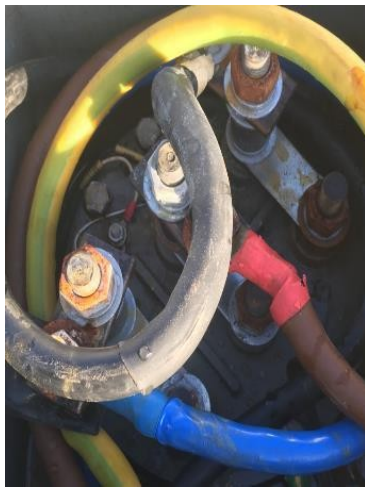
Moisture Ingress, Red Supply Overcrimped

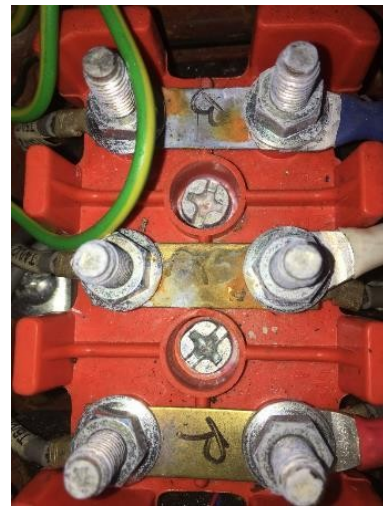
Moisture Ingress, Earth touching two phases

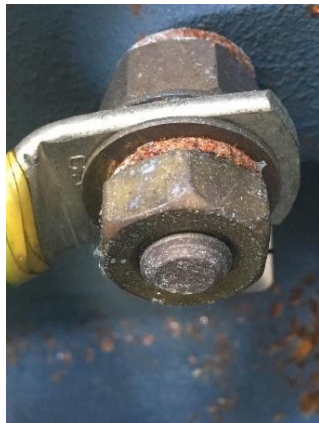
High Resistance to Earth from corrosion

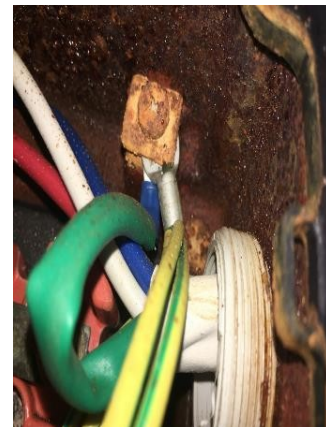
Bad Earth, lots of corrosion

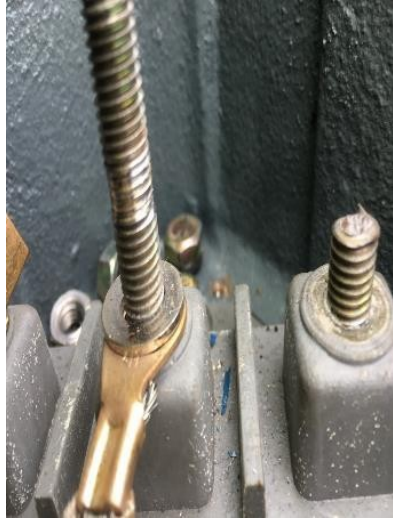
Stripped & Broken studs from poor torque

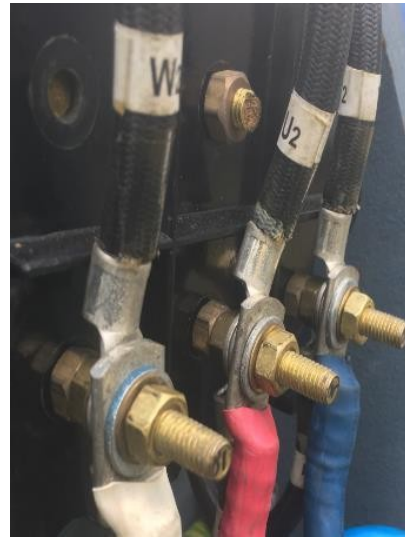
Broken Studs from Over torquing

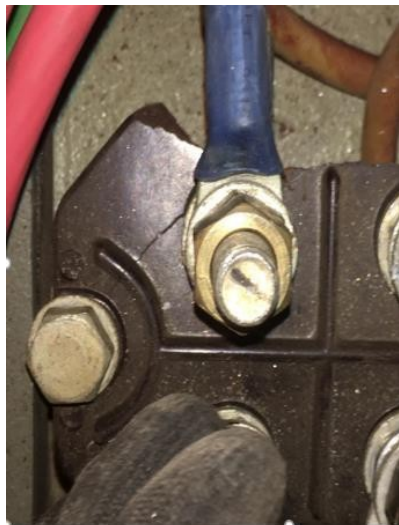
Broken terminal block from Over tightening

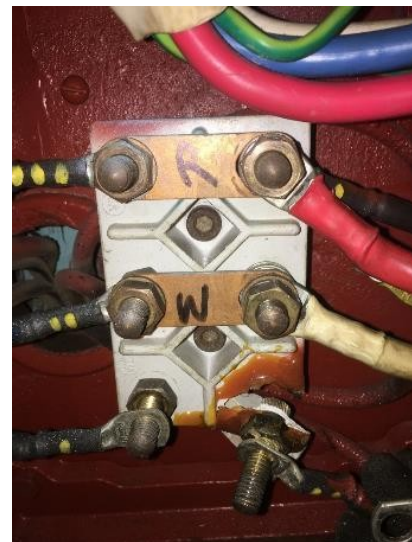
Terminal Block Broken loose

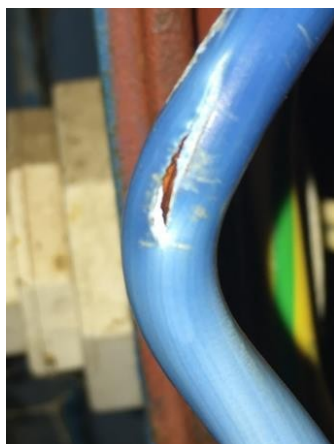
Supply cable damage, bare conductor

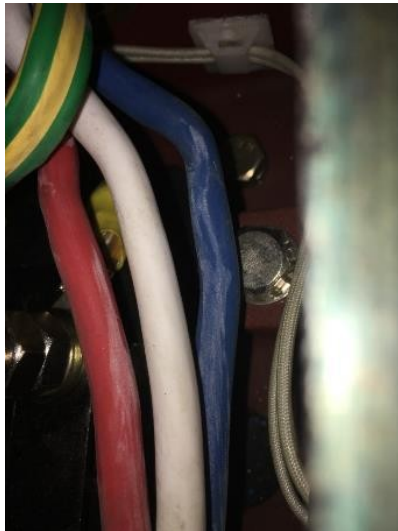
Blue Supply touching Mounting bolt

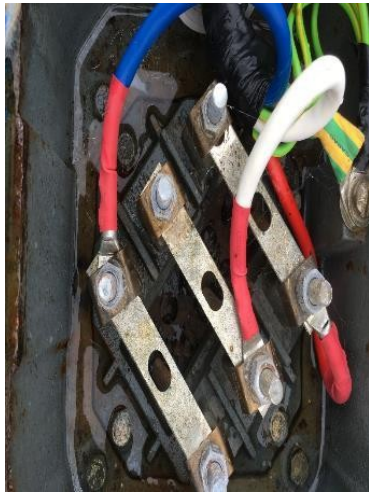
High Resistance due to corrosion

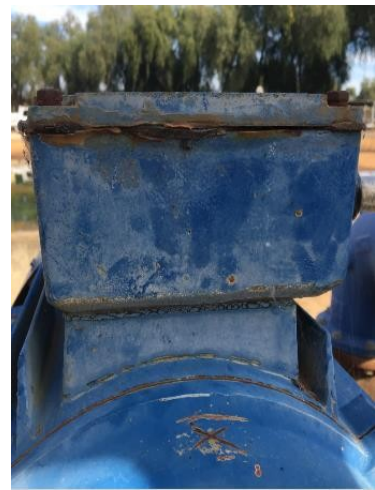
Terminal Box gasket failed
