# CASE STUDY: Successful PdM Saves Facility Time & Money

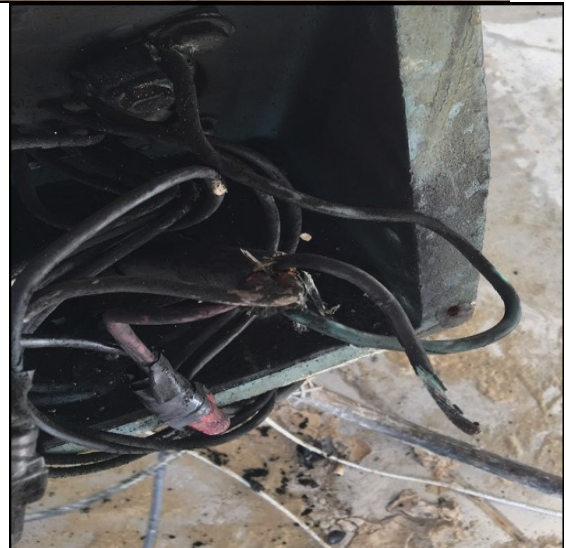
### Condition As Found

A work order was issued by a Waste Water Treatment Plant Technician requesting electrical support due to a failed floating agitator. The breaker had tripped and the mixer is a necessary asset in the treatment process. When Two craftsmen investigated, they found that two wire nuts/splices in the termination box had burned and it was determined that the motor suffered a winding fault using the standard test practices for the field. Preparations were discussed to utilize contractors in the removal of the platform, disassembly of the unit and to repair the set as needed.

- Tripped breaker that would not reset.
- Burned/open terminations and winding fault.
- Standard procedure is to replace failed equipment.

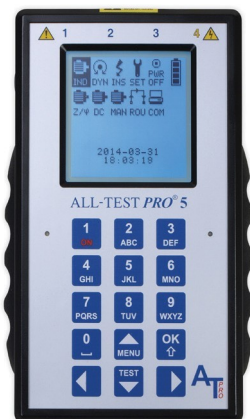
On their own accord, the craftsman requested that the AT5™ be employed before such a costly repair commence. Preliminary tests reported diminished insulation properties for the cabling between the MCC and the motor. A test performed at the motor itself returned a favorable result. Showing that the motor was in fact not failed and could remain in service.

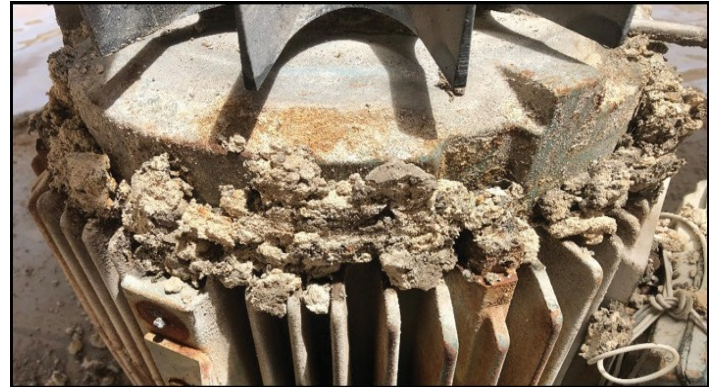
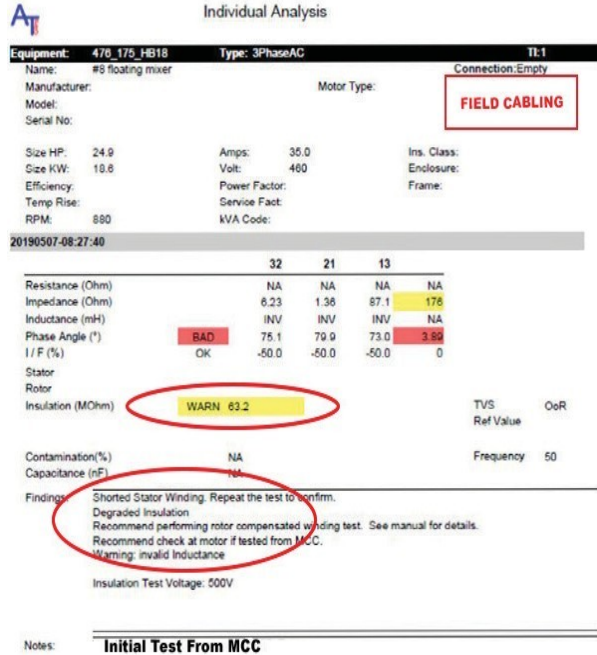
Termination repairs were made and the motor was tested for operation and returned to service. The motor cooling fan shroud was found to be completely full of debris which contributed to high temps and termination failure. This was cleaned resulting in much cooler motor temps. For reference, the last repair (bearings/impeller) for this type of asset was \$6266 and the last motor rewind was \$8600. Also, there is no spare available in their stores.

**AIR FLOW BLOCKED**

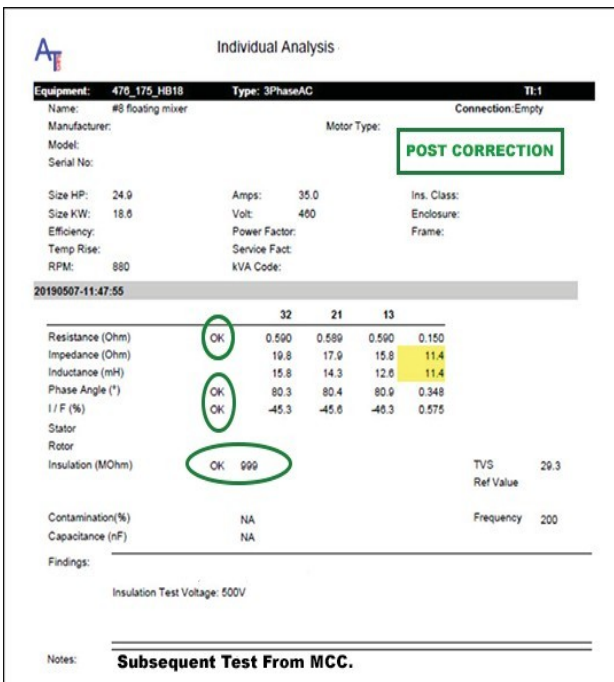
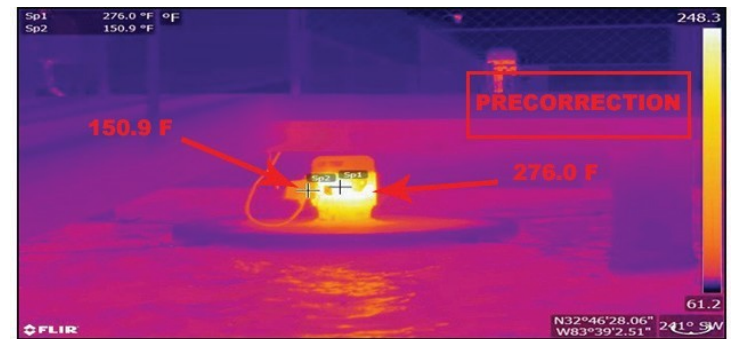
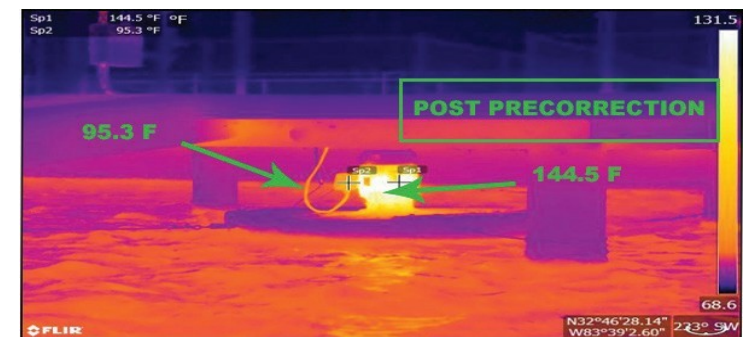
## Current Testing Results

- MCA™ Deenergized testing.
- Additional developing fault identified.
- Although affected by temp, motor receives a passing report.
