## Electrical Signature Analysis Performed on Vertical Turbine Pump Motors in Municipal Application

Authored by William Kruger, Technical & Training Manager, ALL-TEST Pro, LLC, and Alex Panattoni, Control Systems Technician II, City of Henderson Department of Utility Services Electrical Section

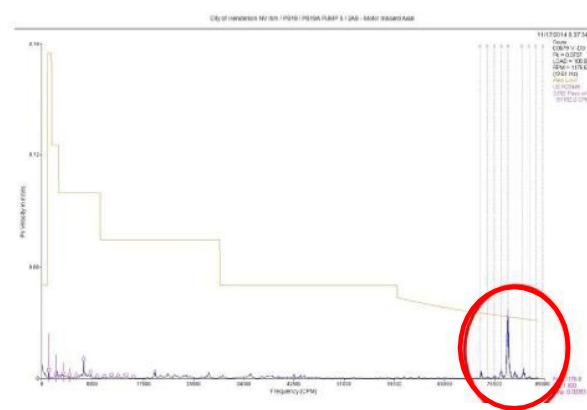
In November 2014, vibration analysis was performed as part of the plant's Predictive Maintenance Program. While those test results suggested the possibility of early bearing degradation in Motor 5, the rotor bar passing frequency was within range (**seeFigure 1**). The vibration summary concluded that systems were operating within acceptable limits and that no maintenance actions needed to be taken at that time.

**Figure 1.** November 17, 2014 - 2AS - Motor Inboard Axial - Acceptable Vibration - Note: High Frequency Vibration ~81,102 cpm is Rotor Bar Passing Frequency. No Maintenance Action Recommended at this time. Continue to Monitor.

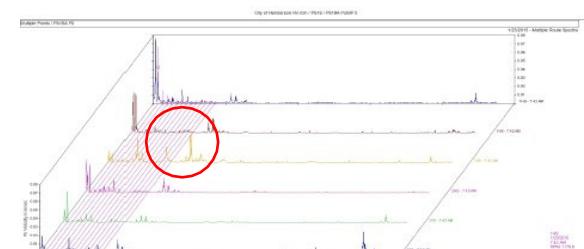
Spectral Waterfall – Data Points 1HS, 1VS, 1AS, 2HS, 2VS, 2AS – Standard Velocity

Figure 2.January 23, 2015- Vibration analysis for Motor 5 indicates the presence of low amplitude non-synchronous energy in the PeakVue timedomain data collected on the upper motor bearing. Only recommendations made were to monitor bearings for further degradation. Vibration analysis gave no indication of potential problems with the rotor.

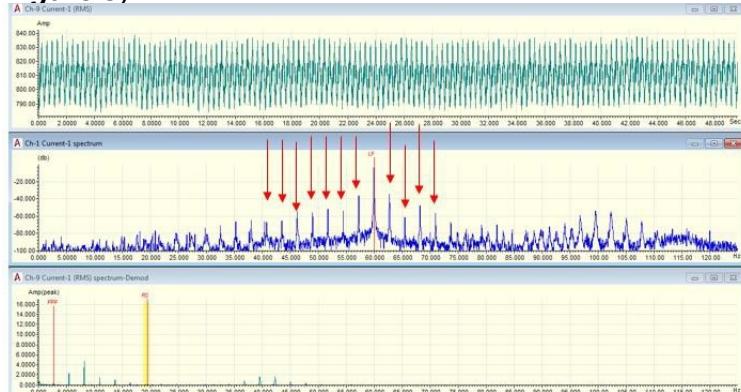
During the energized motor tests, data was taken at different times; first shortly after start-up, then again after the pump had been running. Of significance was the large change in rotor speed with a very small change in motor load. The rotor was running considerably below name plate; after running about thirty minutes, the rotor speed was 1171 RPM. This was also confirmed by an independent tach system provided by the third-party who performed the vibration analysis. While the results of the vibration analysis did not show any indications of rotor problems, the speed and the ESA data taken with the ATPOL II™ indicated that several rotor bars were broken (see

ESA Data from ATPOL II™		
	Pump 1	Pump 5
Pump Speed:	1183 RPM	1175 RPM
Demand Power:	738.98 HP	726.96 HP
Load:	100.7%	99.1%
Output Load:	507.95 KW	495 KW
Severity Rating:	6 out of 7	7 out of 7

The RPM values shown in the chart above are consistent with rotor bar anomalies. Motors 1 & 5 indicate an increased "slip frequency".

**Figure 3.January 2015– Electrical Signature Analysis using the ATPOL II™ - (Before repair) pole pass frequency side bands indicate very severe rotor bar damage; current draw was 820 amps and modulating around 16 amps.**

After discussing the issues with the motor manufacturer and a third party motor repair company, the maintenance team chose to have both Motor 1 and Motor 5 rebuilt with copper rotor bars. Pumps 2, 3, and 4 had copper rotor bars and did not have the same issues as Pumps 1 and 5. The original rotor bars in Pump 1 and Pump 5 had been made of aluminum. This was believed to be the root cause of the problem. Because the motors at P-19A normally run 100% to 110% of load, there is a high current flowing through the rotor. This produces heat that causes expansion and contraction. Over a period of time, the aluminum rotor bar breaks under tension, then the arcing occurs at the spot of the break. The currents are then forced through the remaining bars, putting more loads on them and causing more broken bars, weakening the strength of the entire rotor. This issue would have eventually shorted out the stator winding by the increased operating temperature or arcing metal from the rotor, and would have caused the need for a rewind or possible scrapping of the entire motor, in addition to the repair or replacement of the rotor. Having the motors rebuilt with copper rotor bars enabled the maintenance team to avoid catastrophic failure of their vertical turbine pump motors.

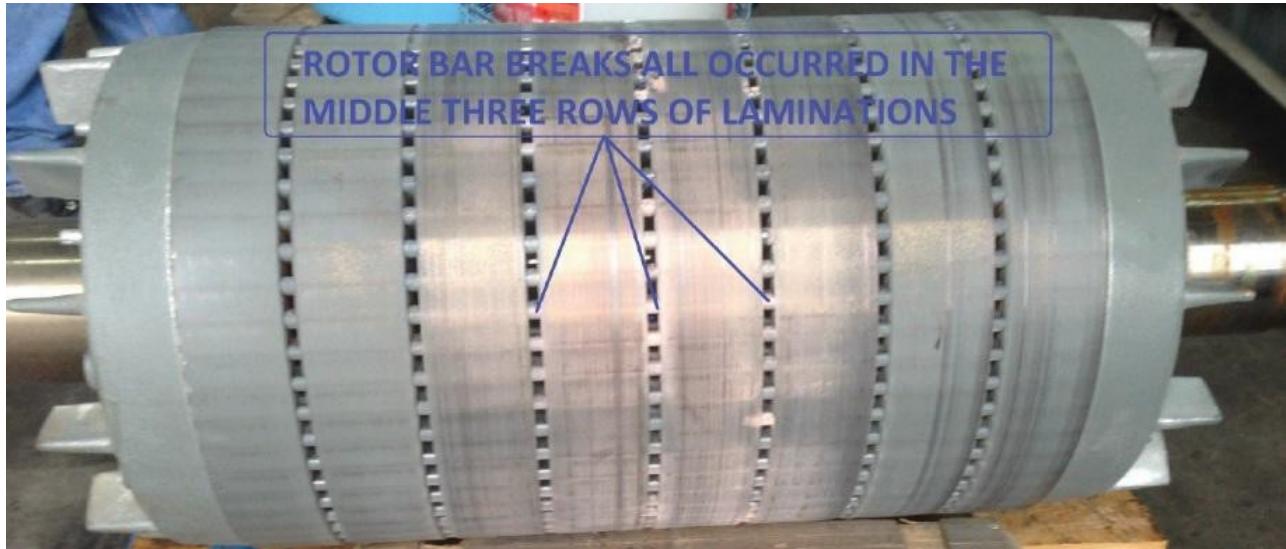
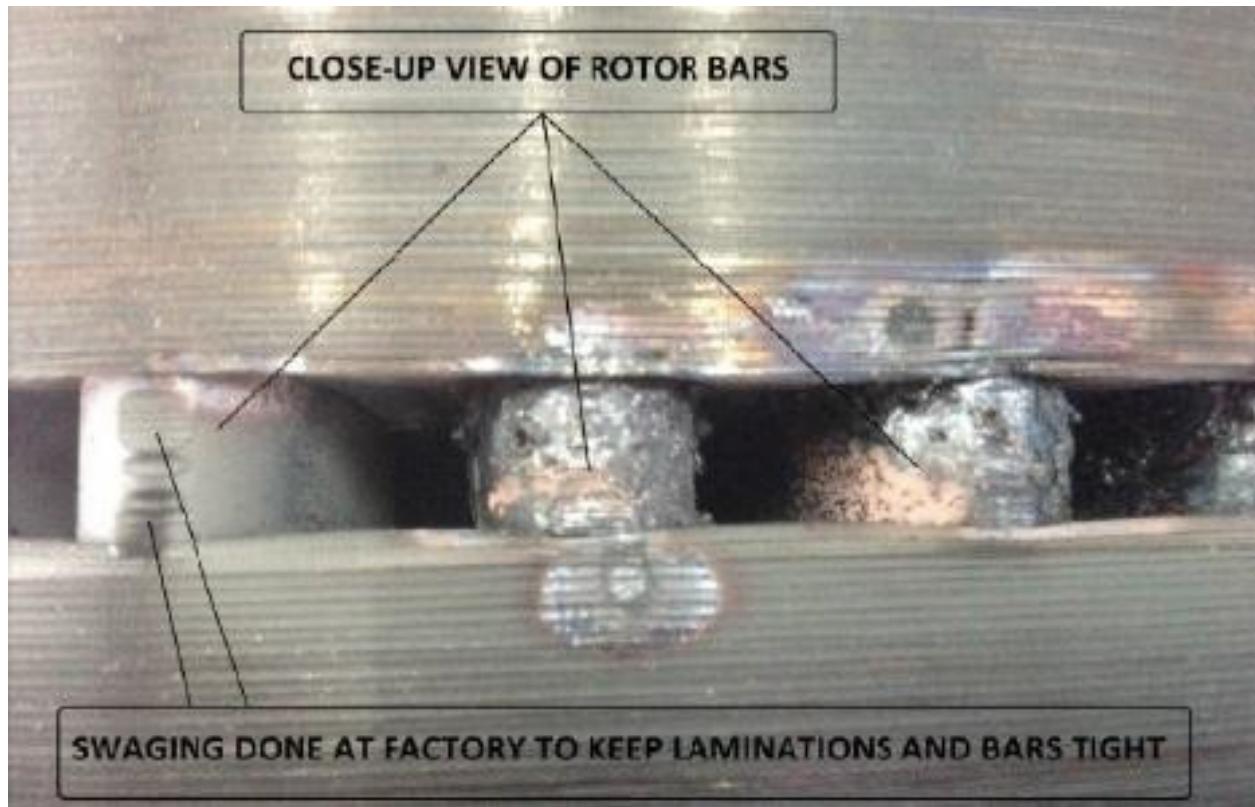
Rotor bars are solid continuous bars that run through the rotor's steel laminations, which are spaced to allow air flow to cool the rotor. Once the maintenance team received the report from the Electrical Signature Analysis, which showed severe indications of rotor bar issues (Pump 1 had a severity rating of 6 out of 7 and Pump 5 had a severity rating of 7 out of 7), they pulled Motor 5 and found that **30% of the rotor bars were in fact broken**.

*Rotor bar breaks all occurred in the middle three rows of laminations.*

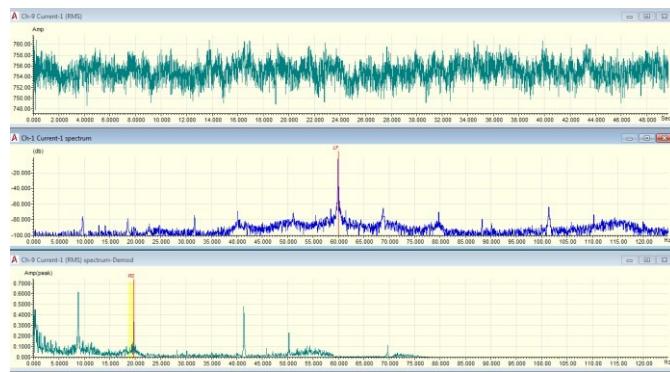
Motor 5 was rebuilt and installed in May of 2015. Another round of MVA and ESA testing was performed immediately after installation to ensure proper operation. The electrical signatures taken in May reported excellent rotor condition (**seeFigure 4**). It also showed that rotor speed increased, while overall current dropped. The newly rebuilt Motor 1 was installed in September 2015 and a third round of testing was performed.

**Figure 4.**May 5, 2015– Electrical Signature Analysis using the ATPOL II™ - (After repair) pole pass frequency side bands were gone and current draw was 754 amps with 2 amps modulation.
