MOTOR CIRCUIT ANALYSIS TESTING AT WATERSURE USING ALLTEST PRO 5 ANALYSER.

- TO UNDERSTAND TRUE CONDITION OF PLANT CRITICAL MOTORS.
- TO REPLACE/OVERHAUL MOTORS BEFORE CATASTROPHIC FAILURE OCCURS.
- TO HELP ENSURE MOTOR AND PLANT RELIABILITY INTO THE FUTURE AT WATERSURE.

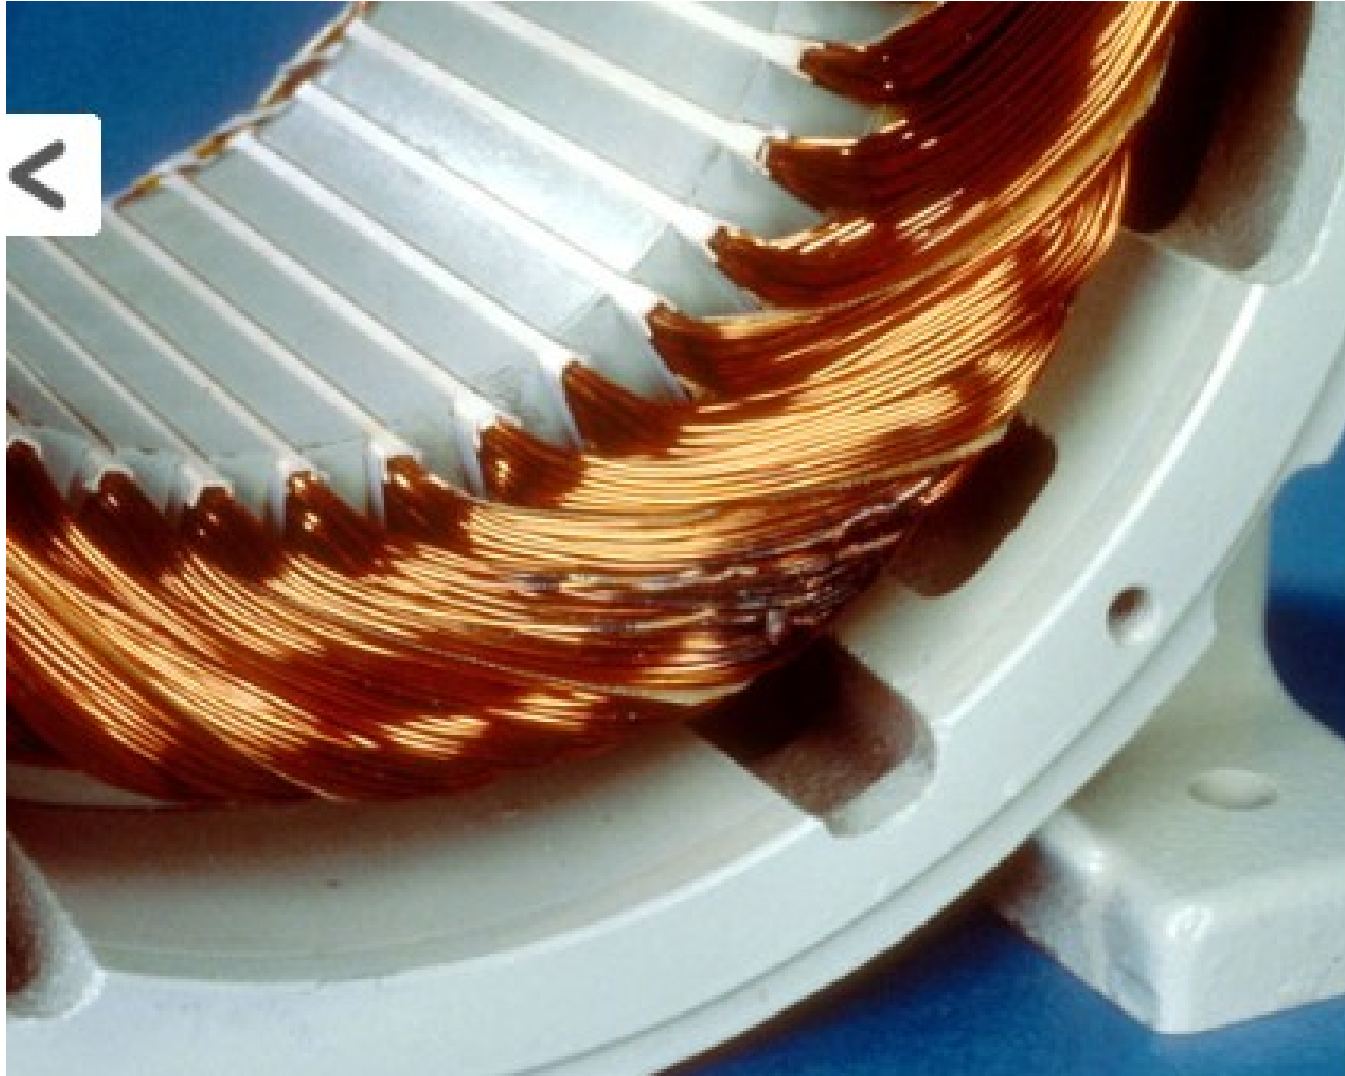
TURN TO TURN WINDING SHORT

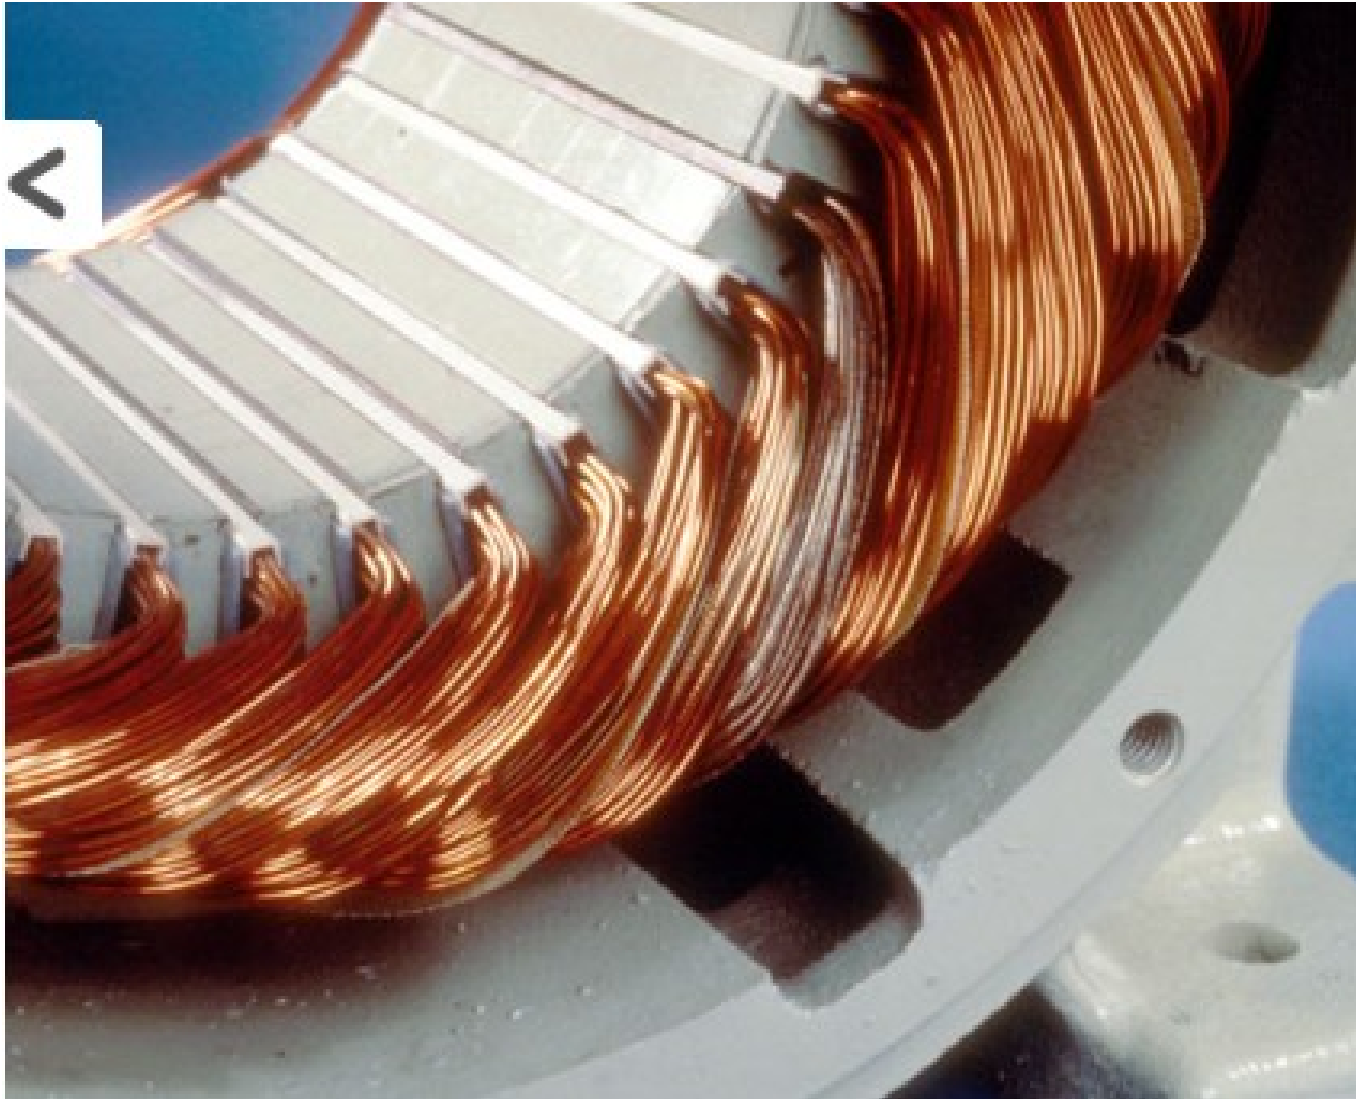
COIL TO COIL WINDING SHORT:

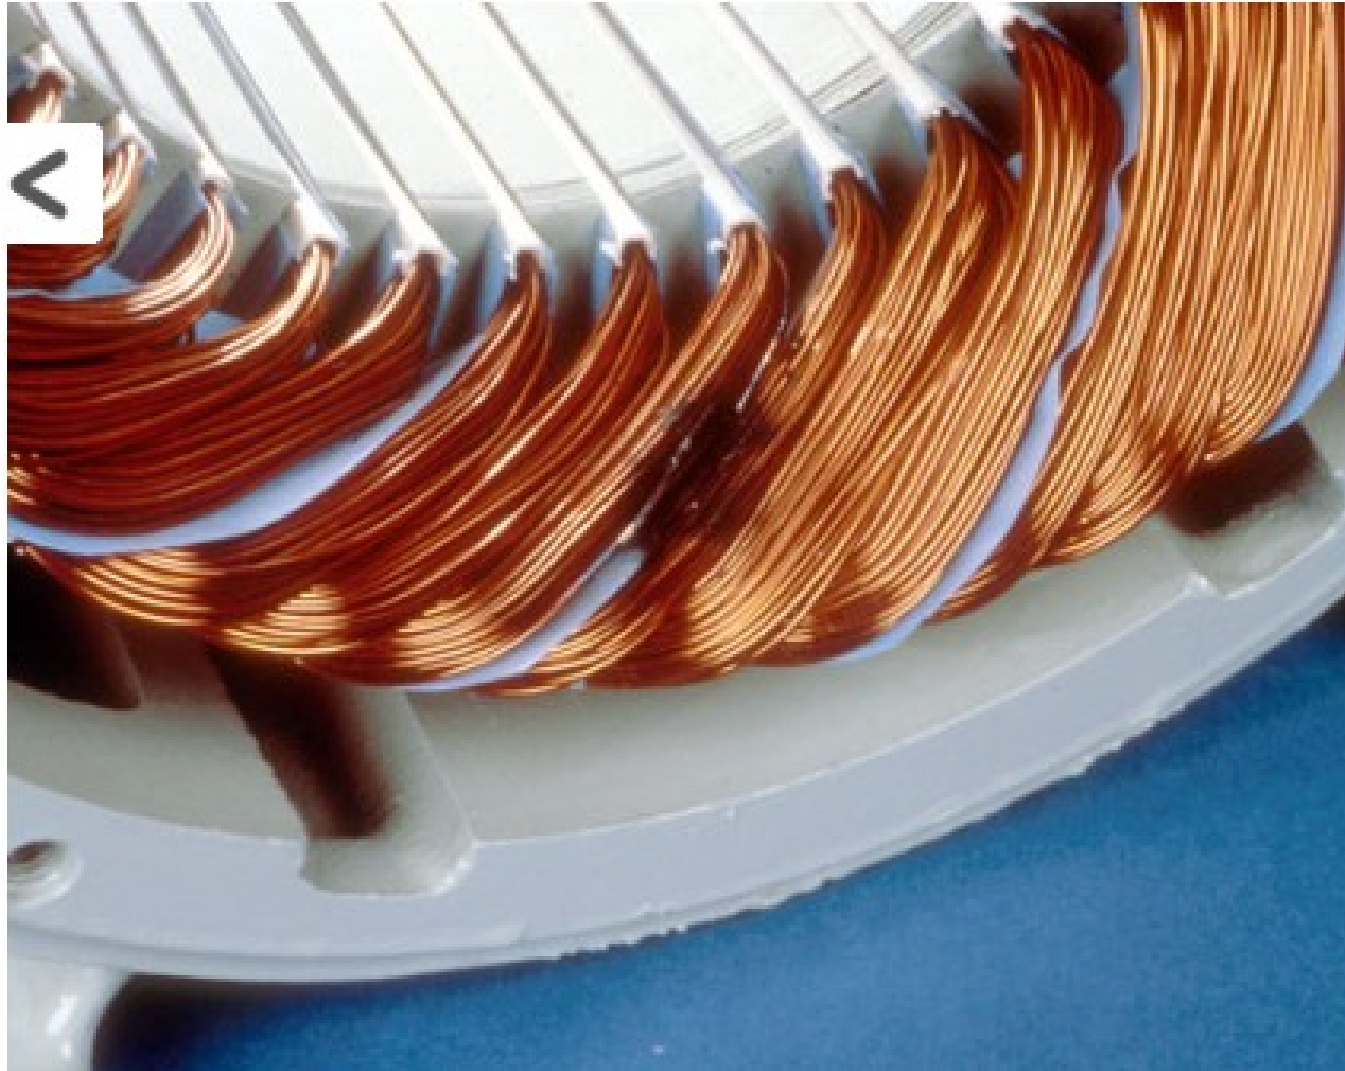
PHASE TO PHASE WINDING SHORT:

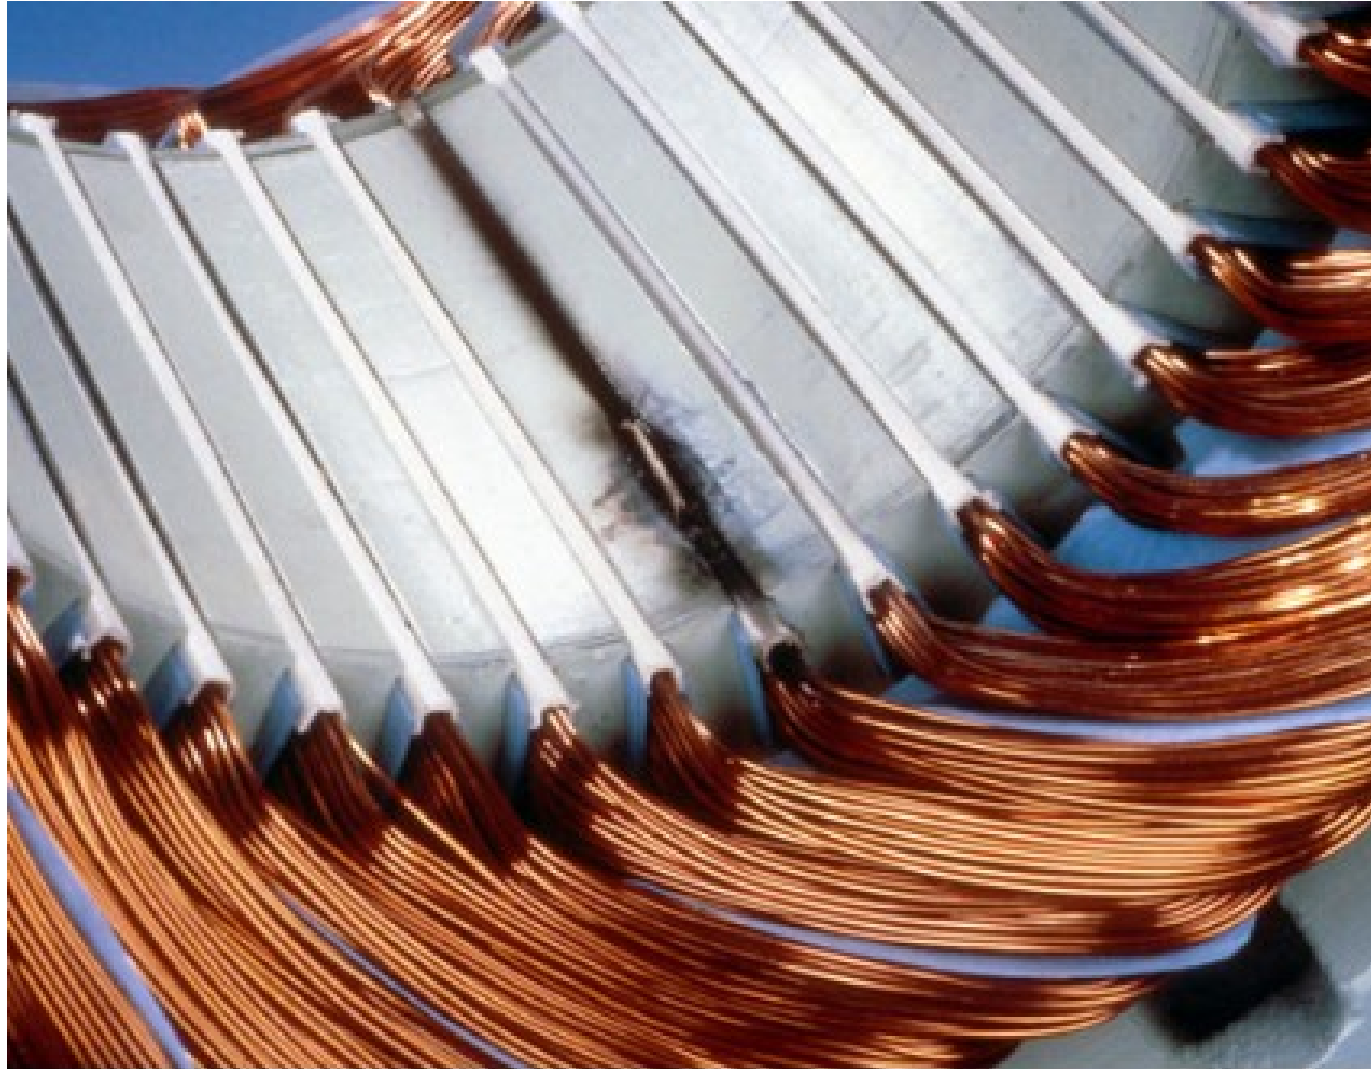
WINDING SHORTED IN
STATOR SLOT:

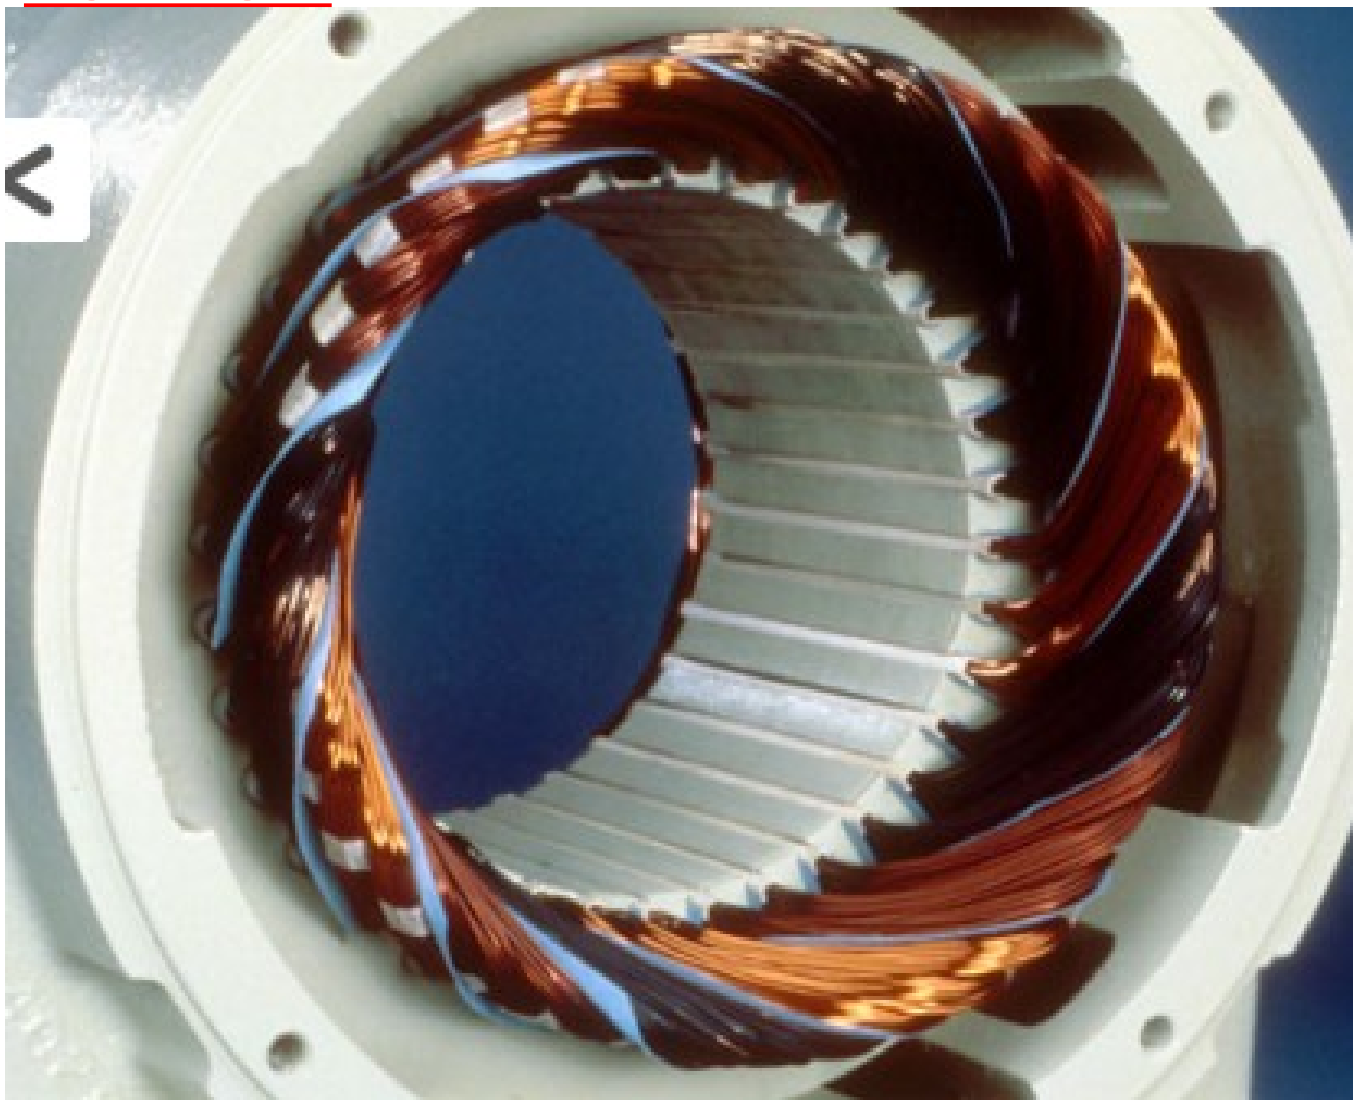
PHASE DAMAGE DUE TO UNBALANCED VOLTAGE:

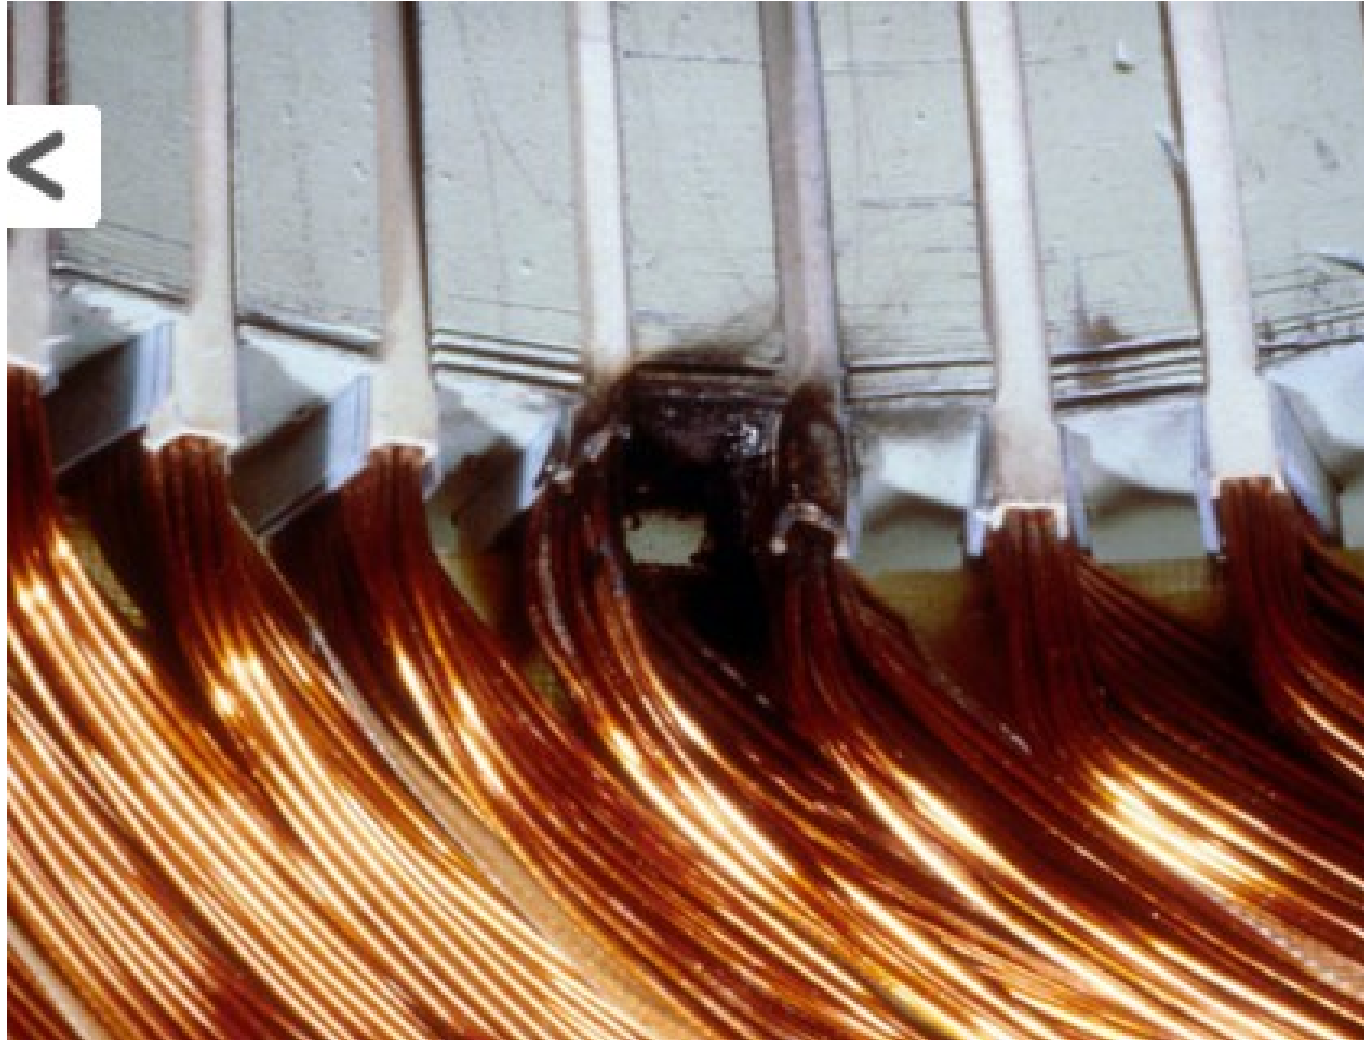
SHORT AT EDGE OF STATOR SLOT:

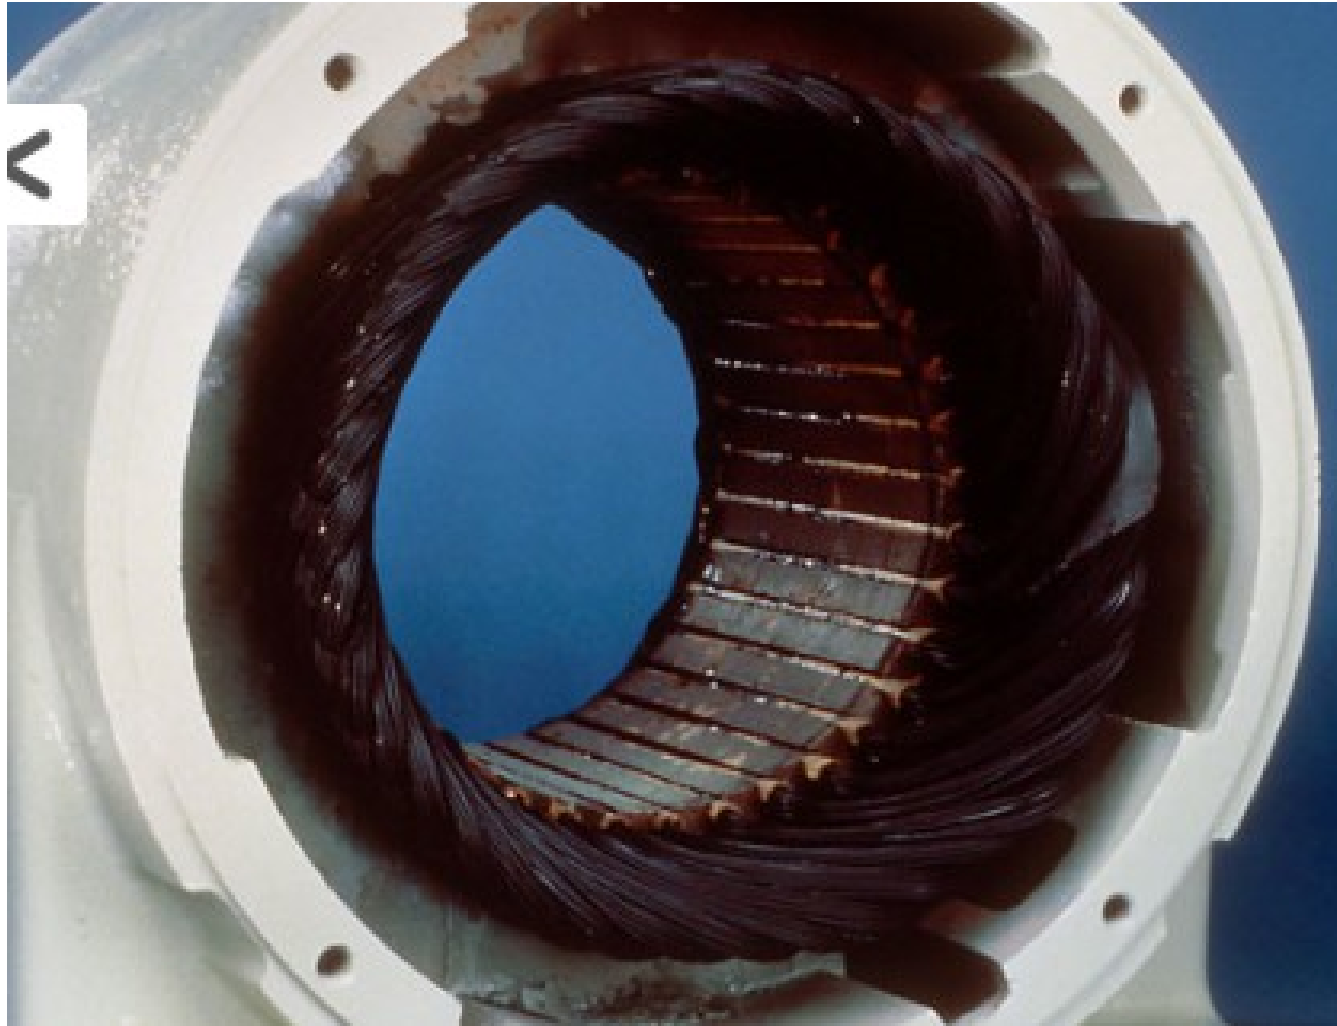
WINDING DAMAGED DUE TO OVERLOAD:

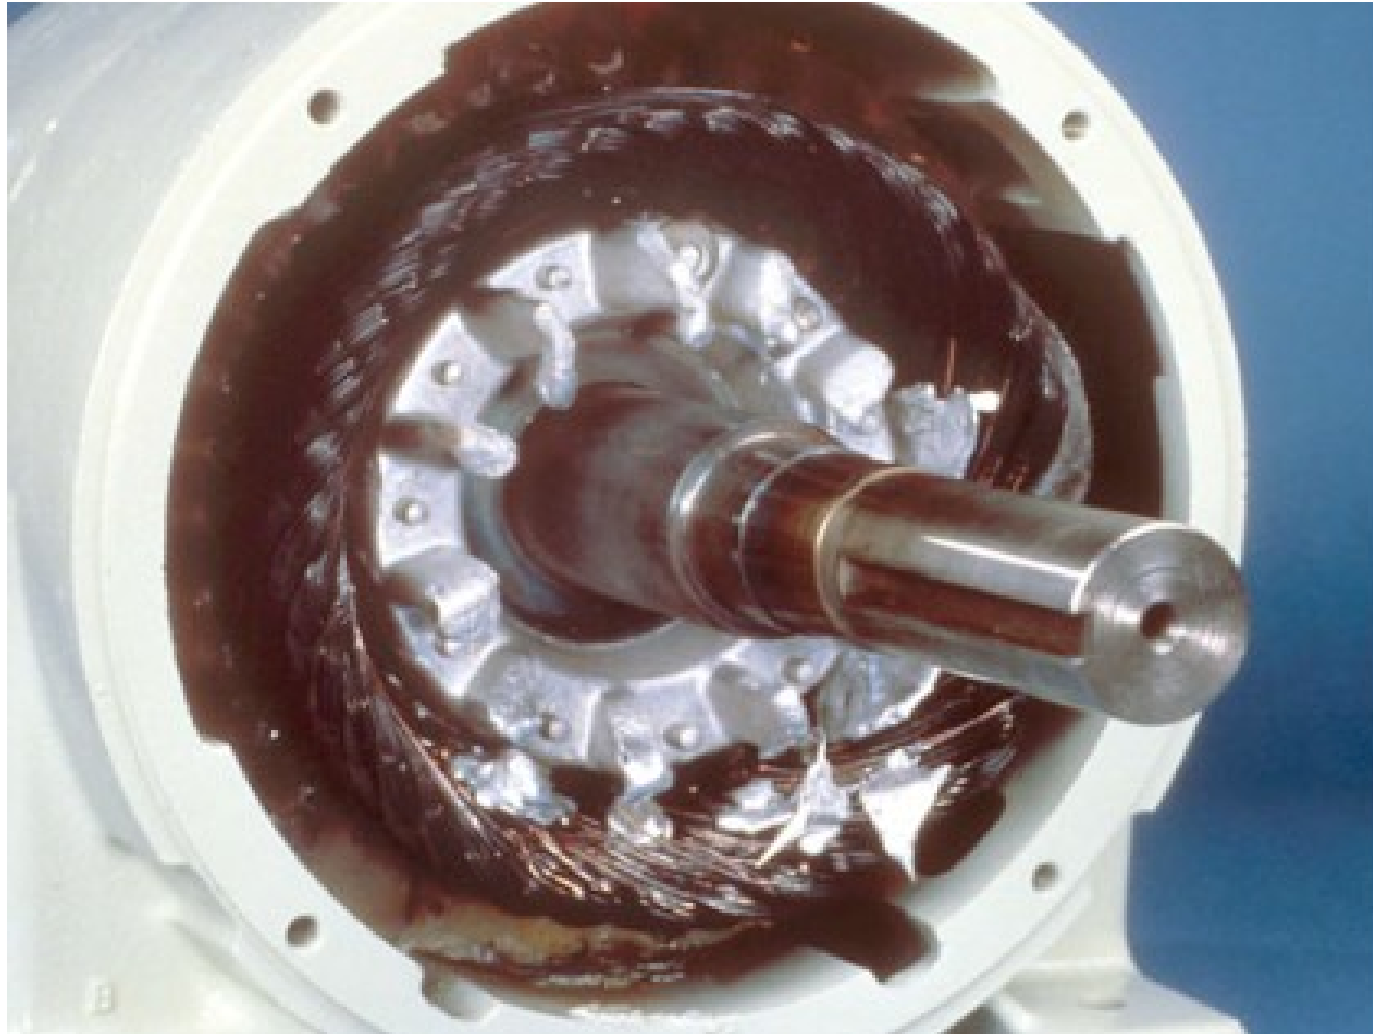
DAMAGED CAUSED BY LOCK ROTOR:

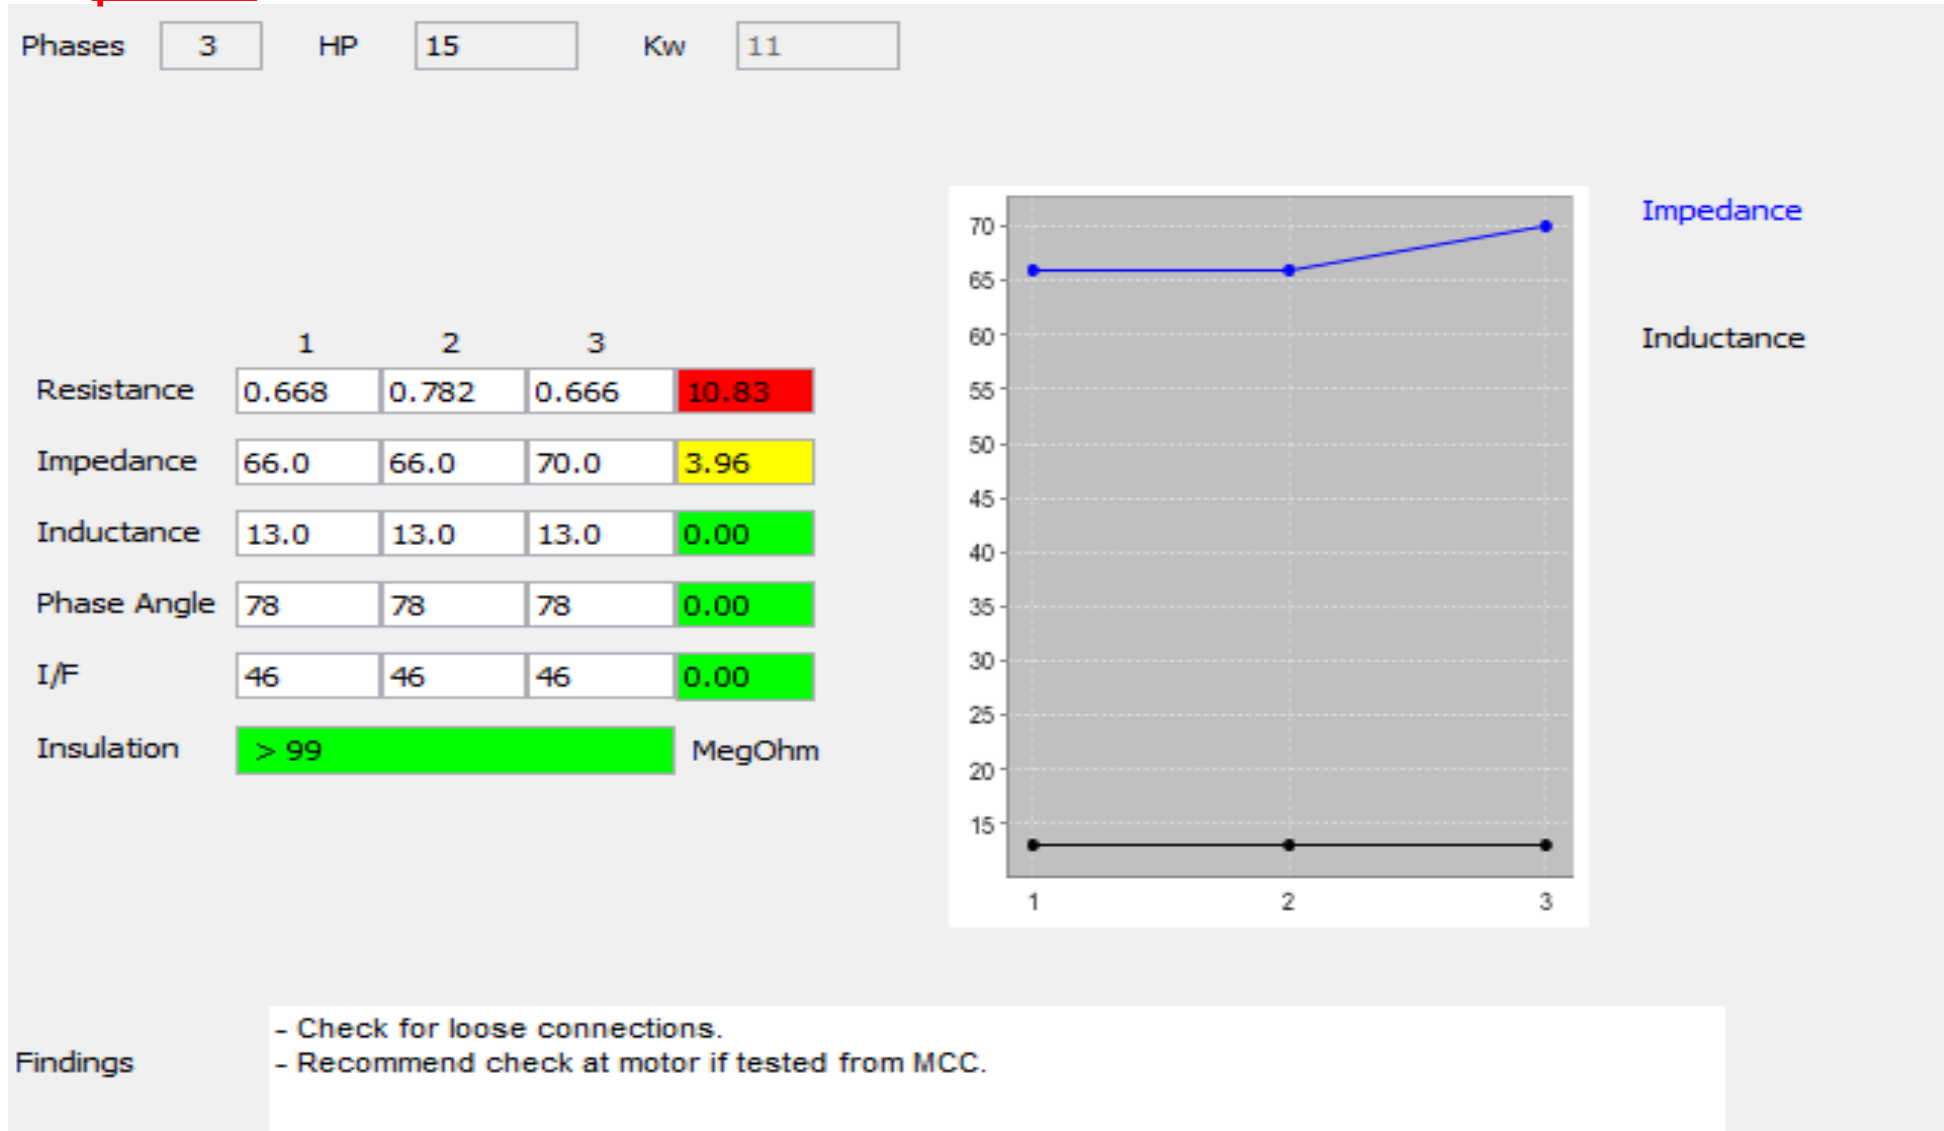
Resistance imbalance on a water pump using all-test pro 4

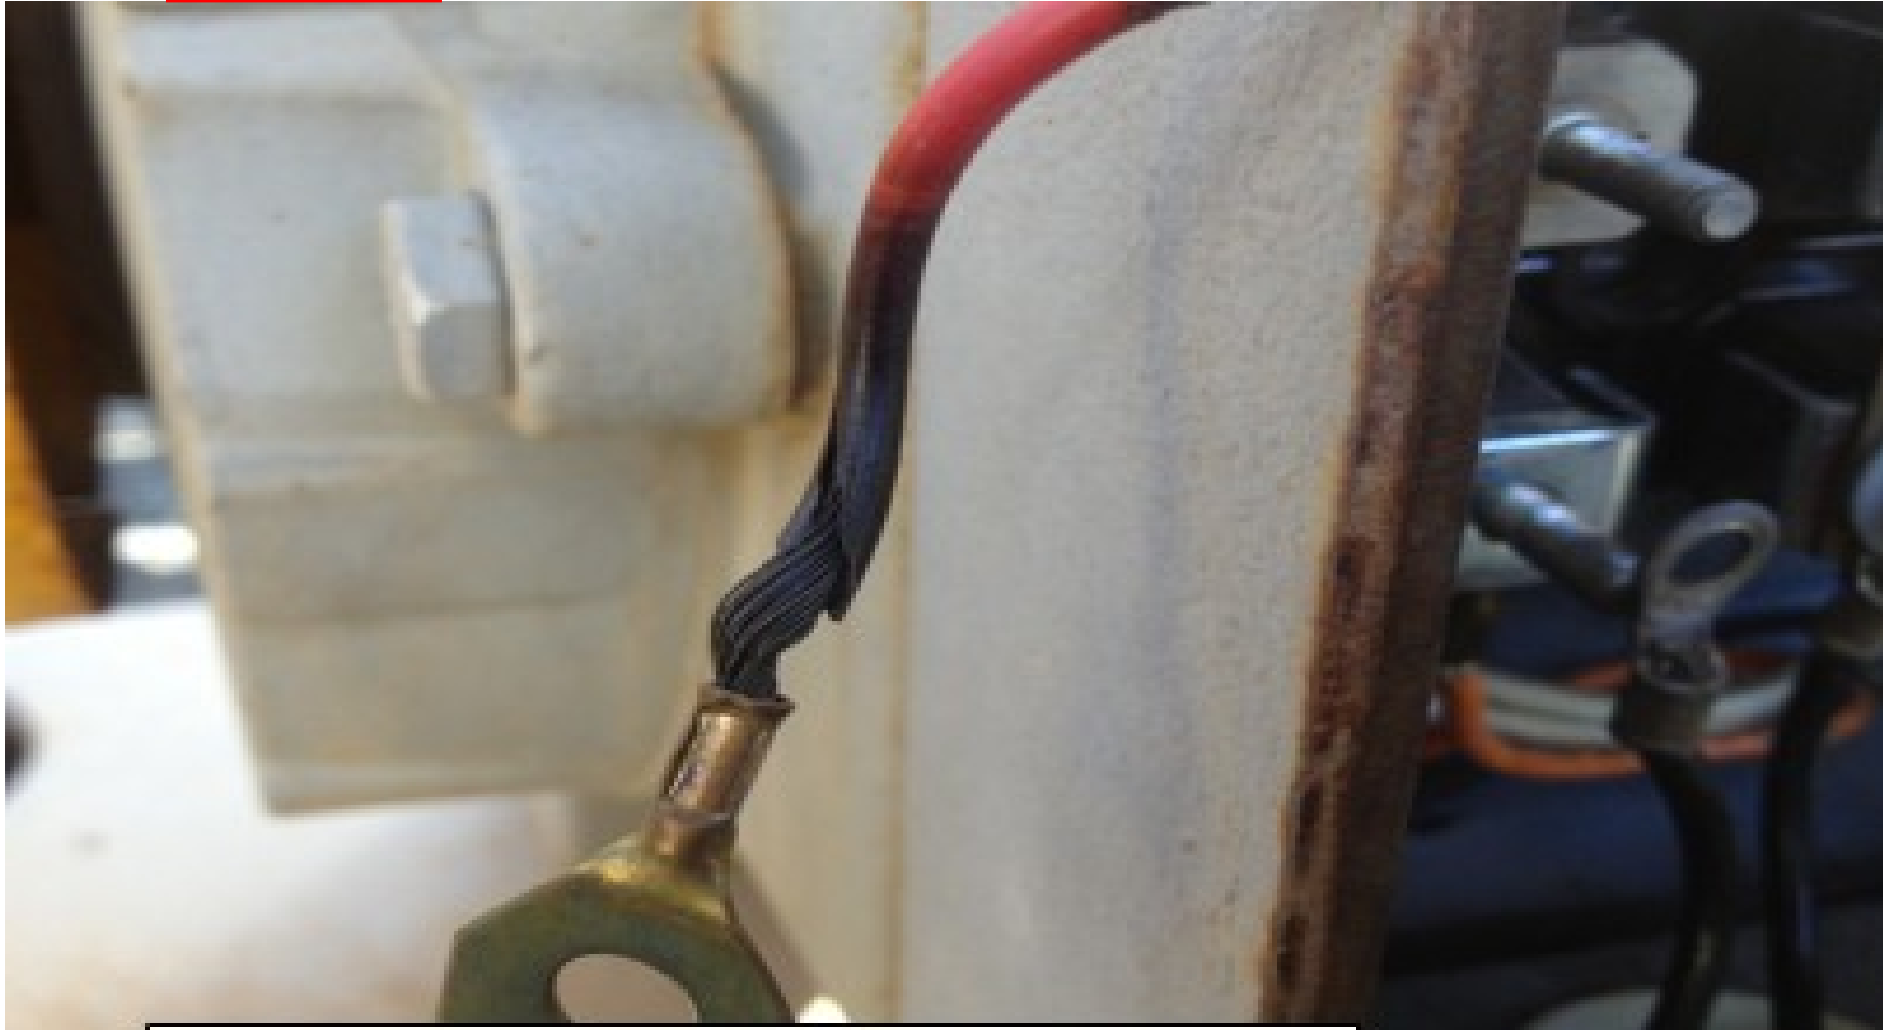
Loose connection causing overheated supply lead to motor

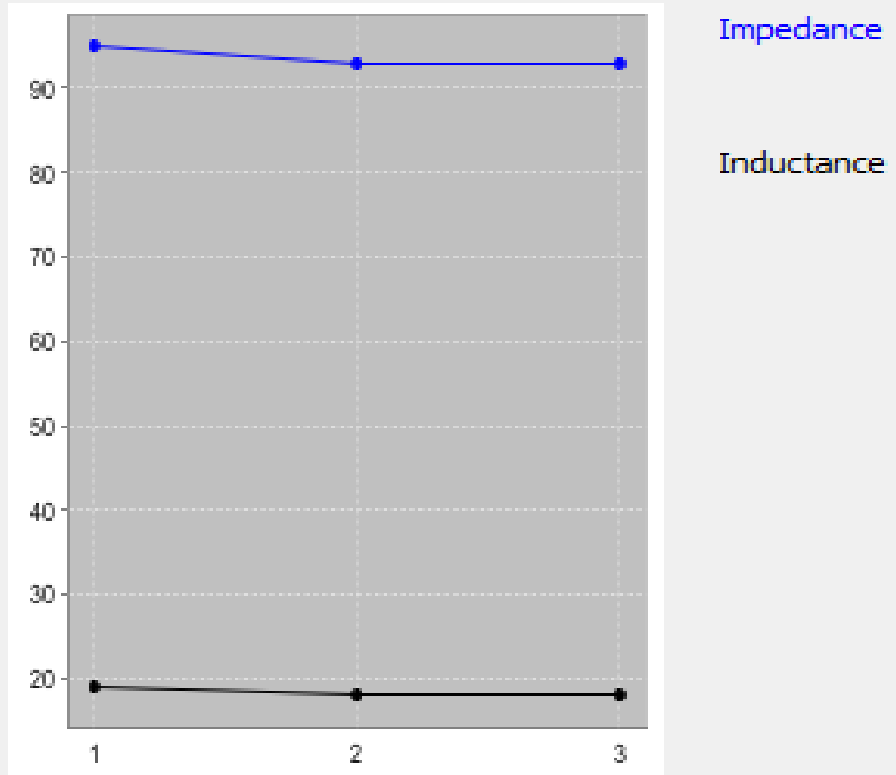
MCA results after repairs carried out. Resistance now balanced.

- No insulation resistance tested.
Good winding.

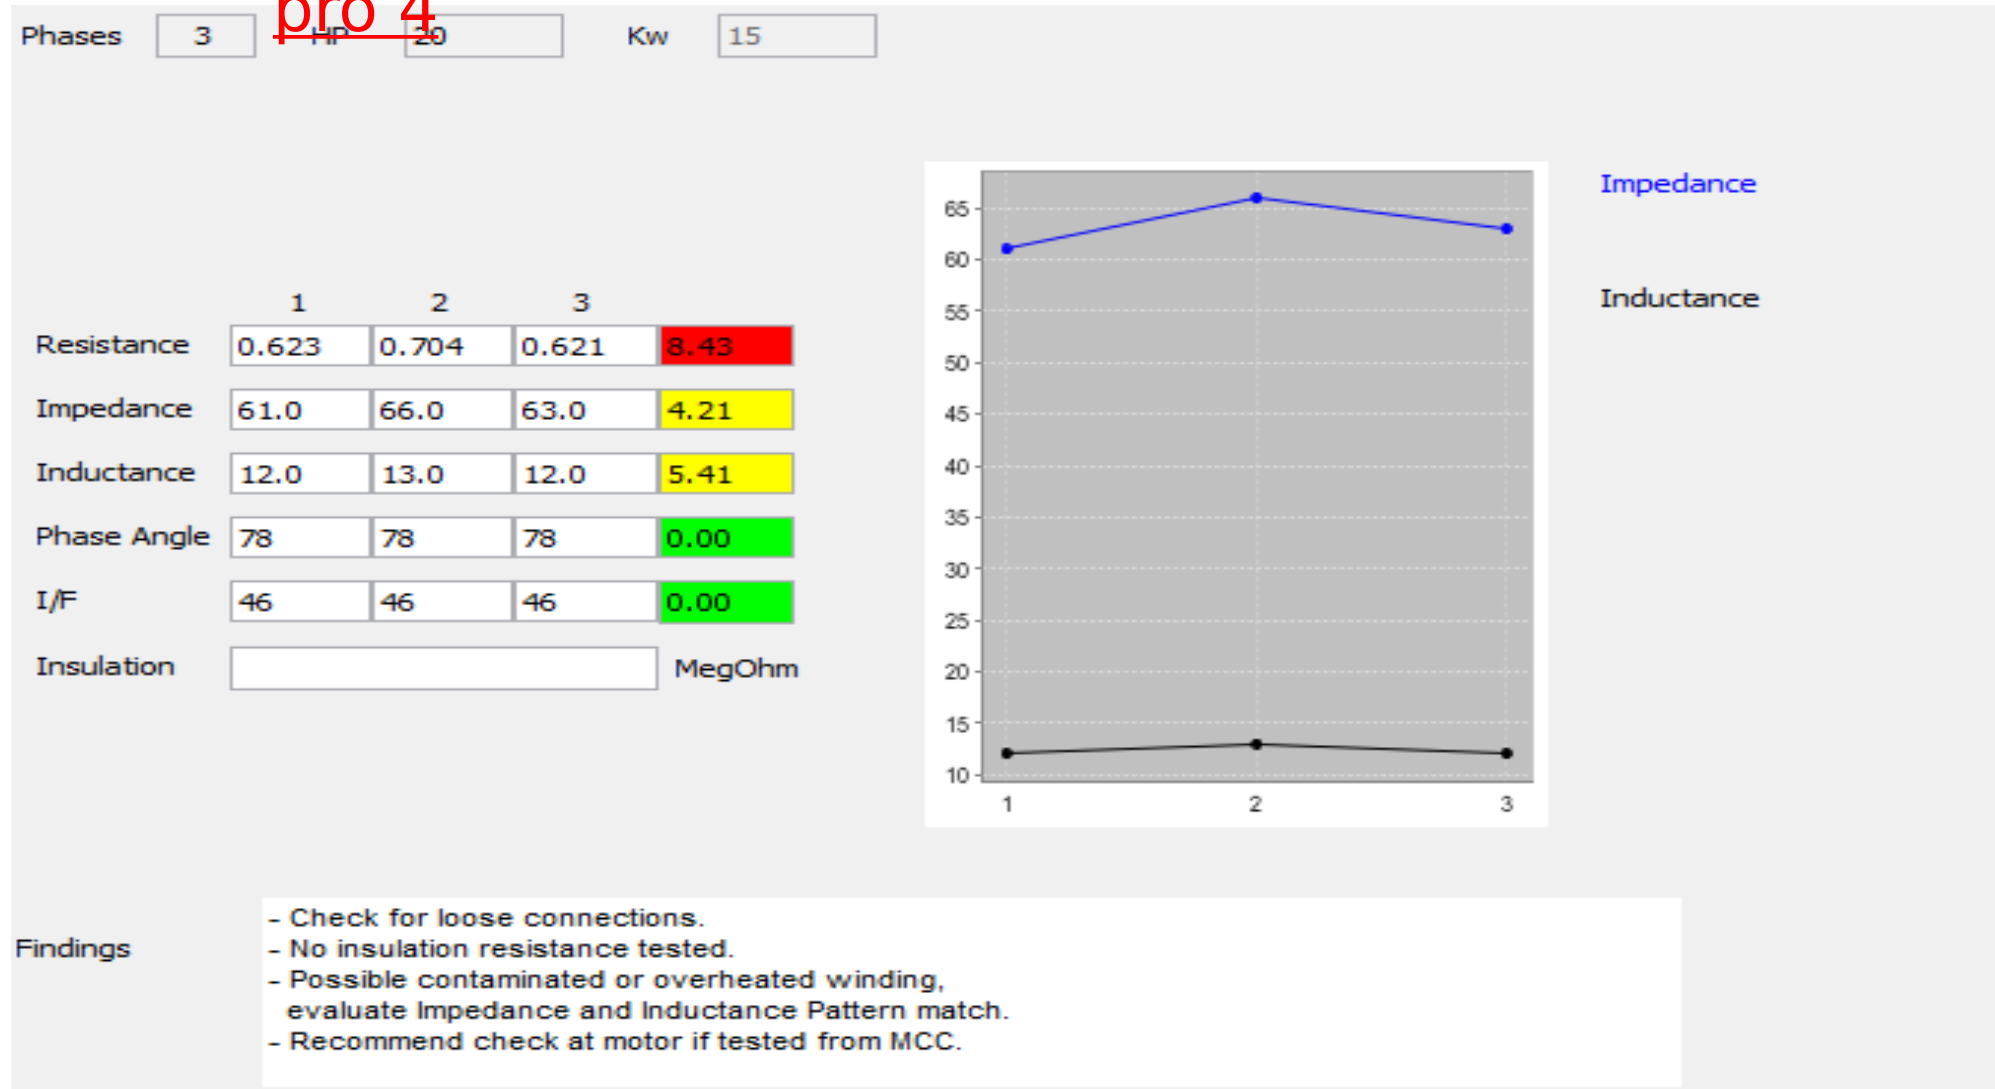
Resistance imbalance on a cooling fan using all-test pro 4

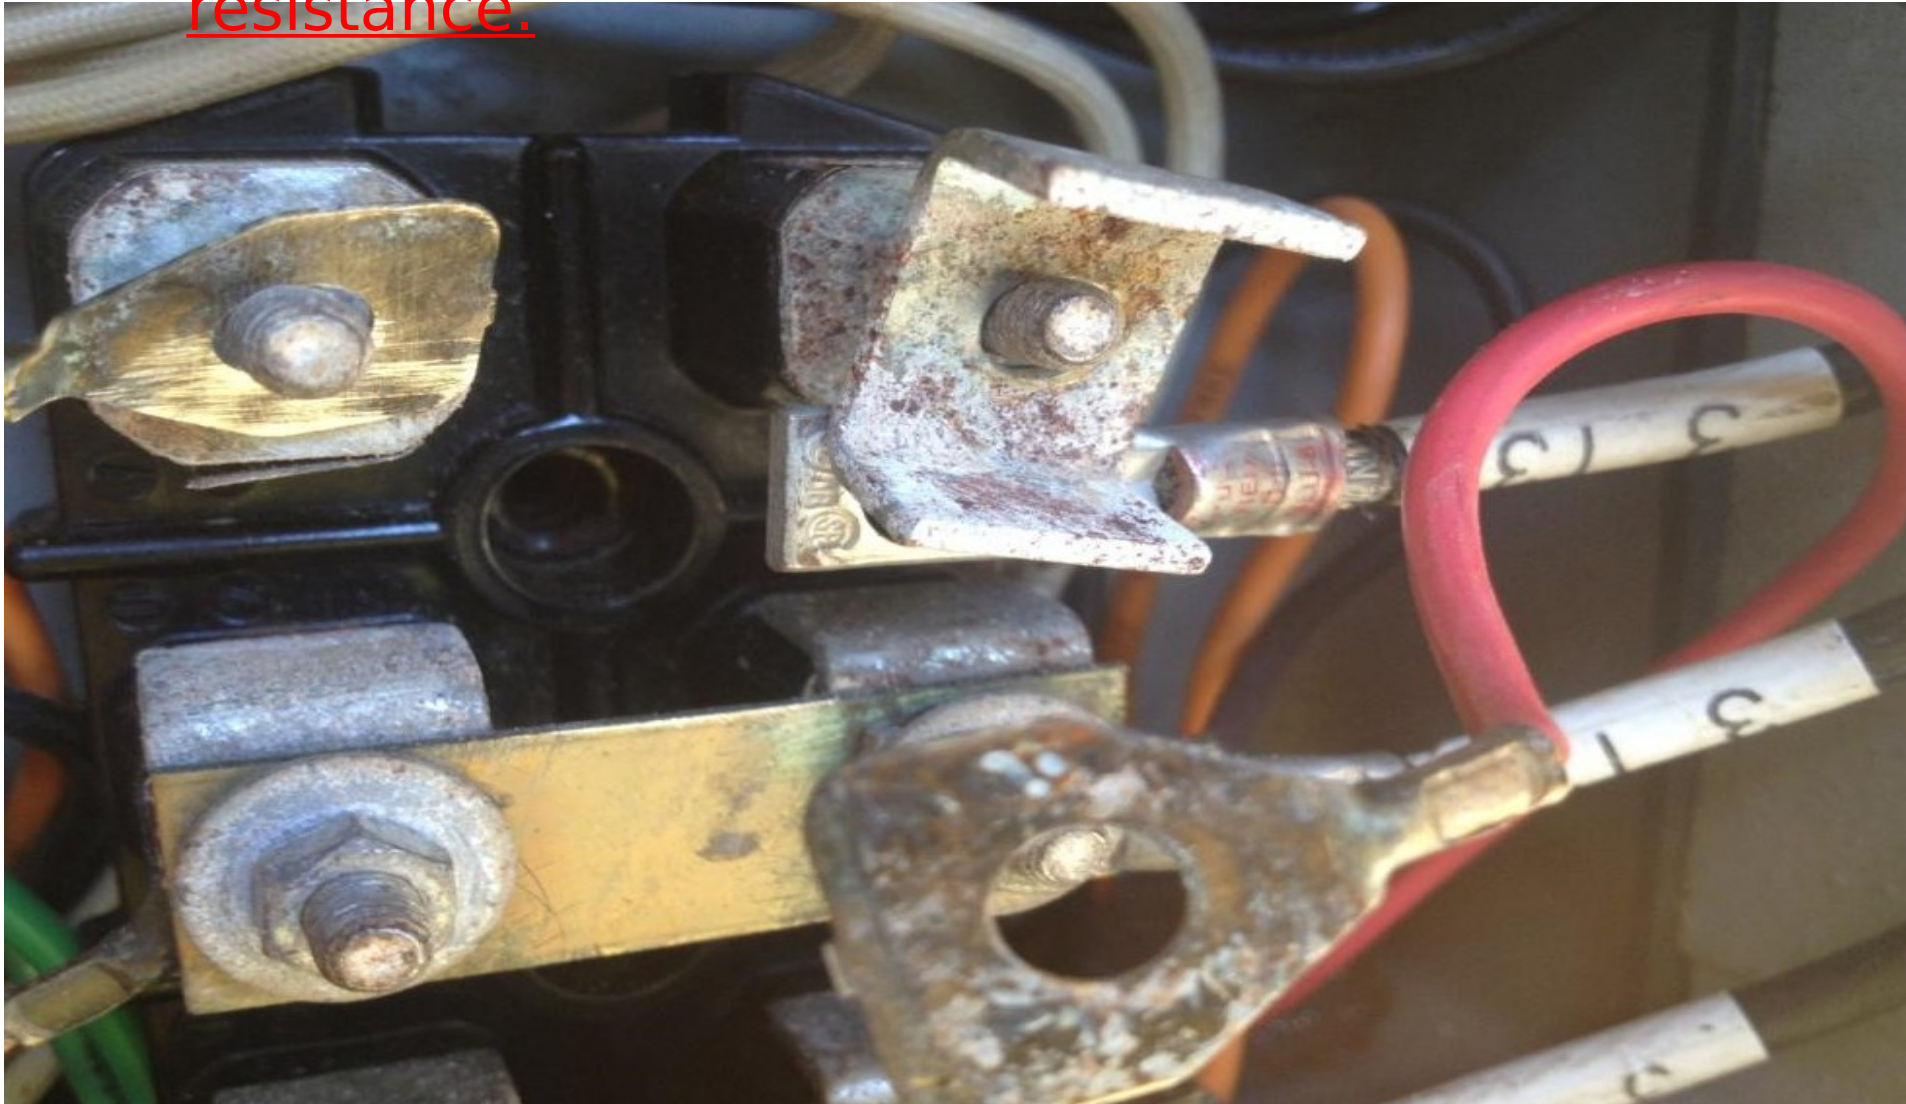
Corroded connections causing increased resistance.

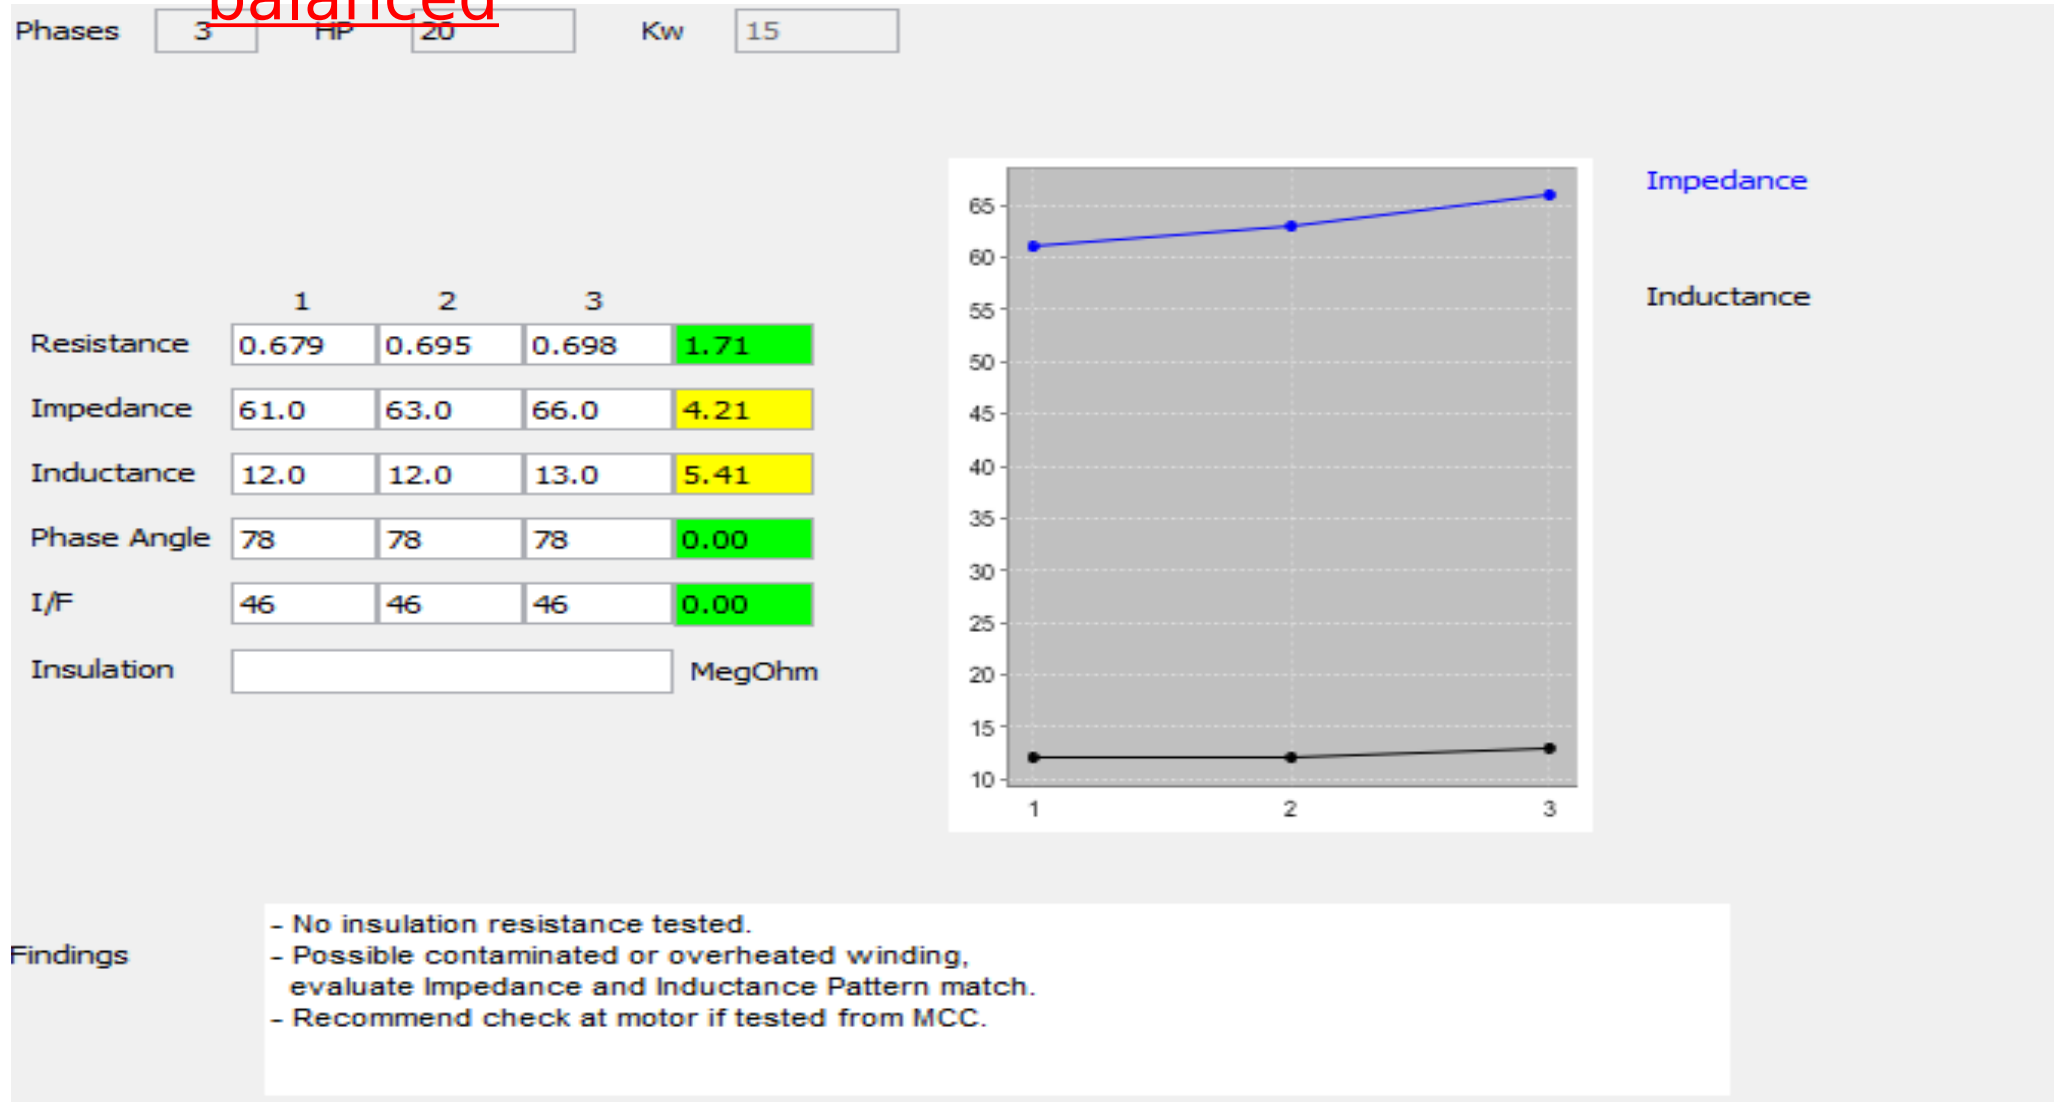
MCA results after repairs carried out. Resistance now balanced
