MOTOR CIRCUIT ANALYSIS TESTING AT WATERSURE USING ALLTEST PRO 5 ANALYSER.

- TO UNDERSTAND TRUE CONDITION OF PLANT CRITICAL MOTORS.
- TO REPLACE/OVERHAUL MOTORS BEFORE CATASTROPHIC FAILURE OCCURS.
- TO HELP ENSURE MOTOR AND PLANT RELIABILITY INTO THE FUTURE AT WATERSURE.

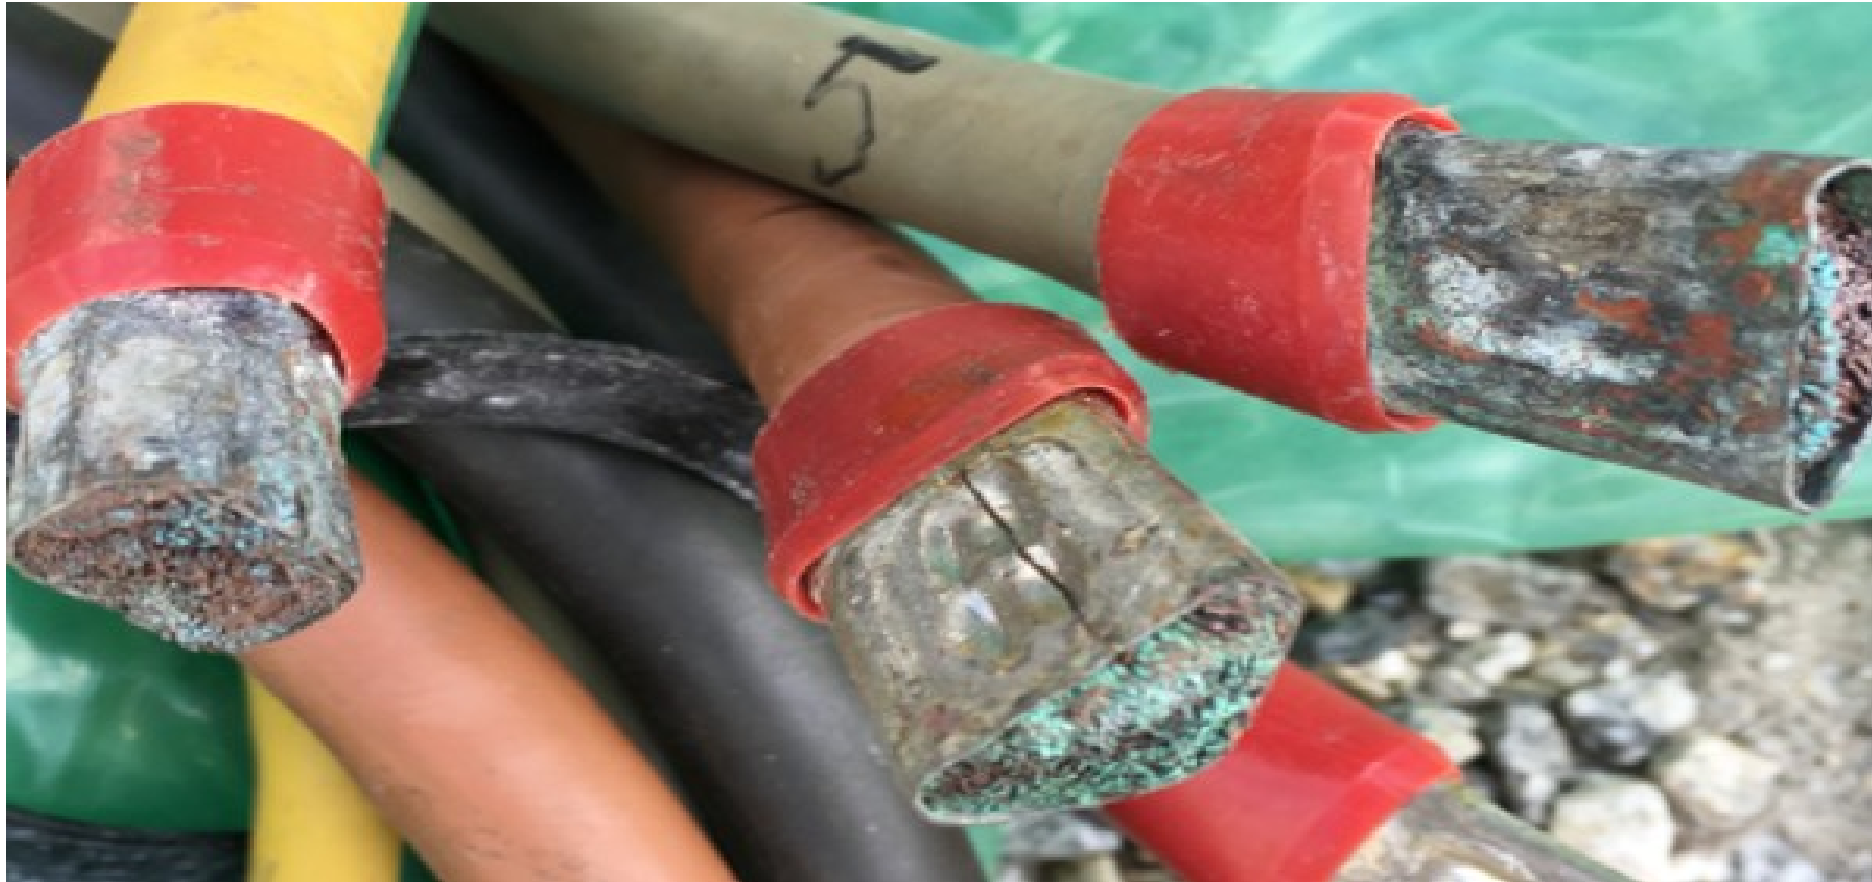
Check for loose connections.

Watersure sea water lift pump motor corroded lugs

Recommend check at motor if tested from MCC.
Insulation Test Voltage: 1,000V

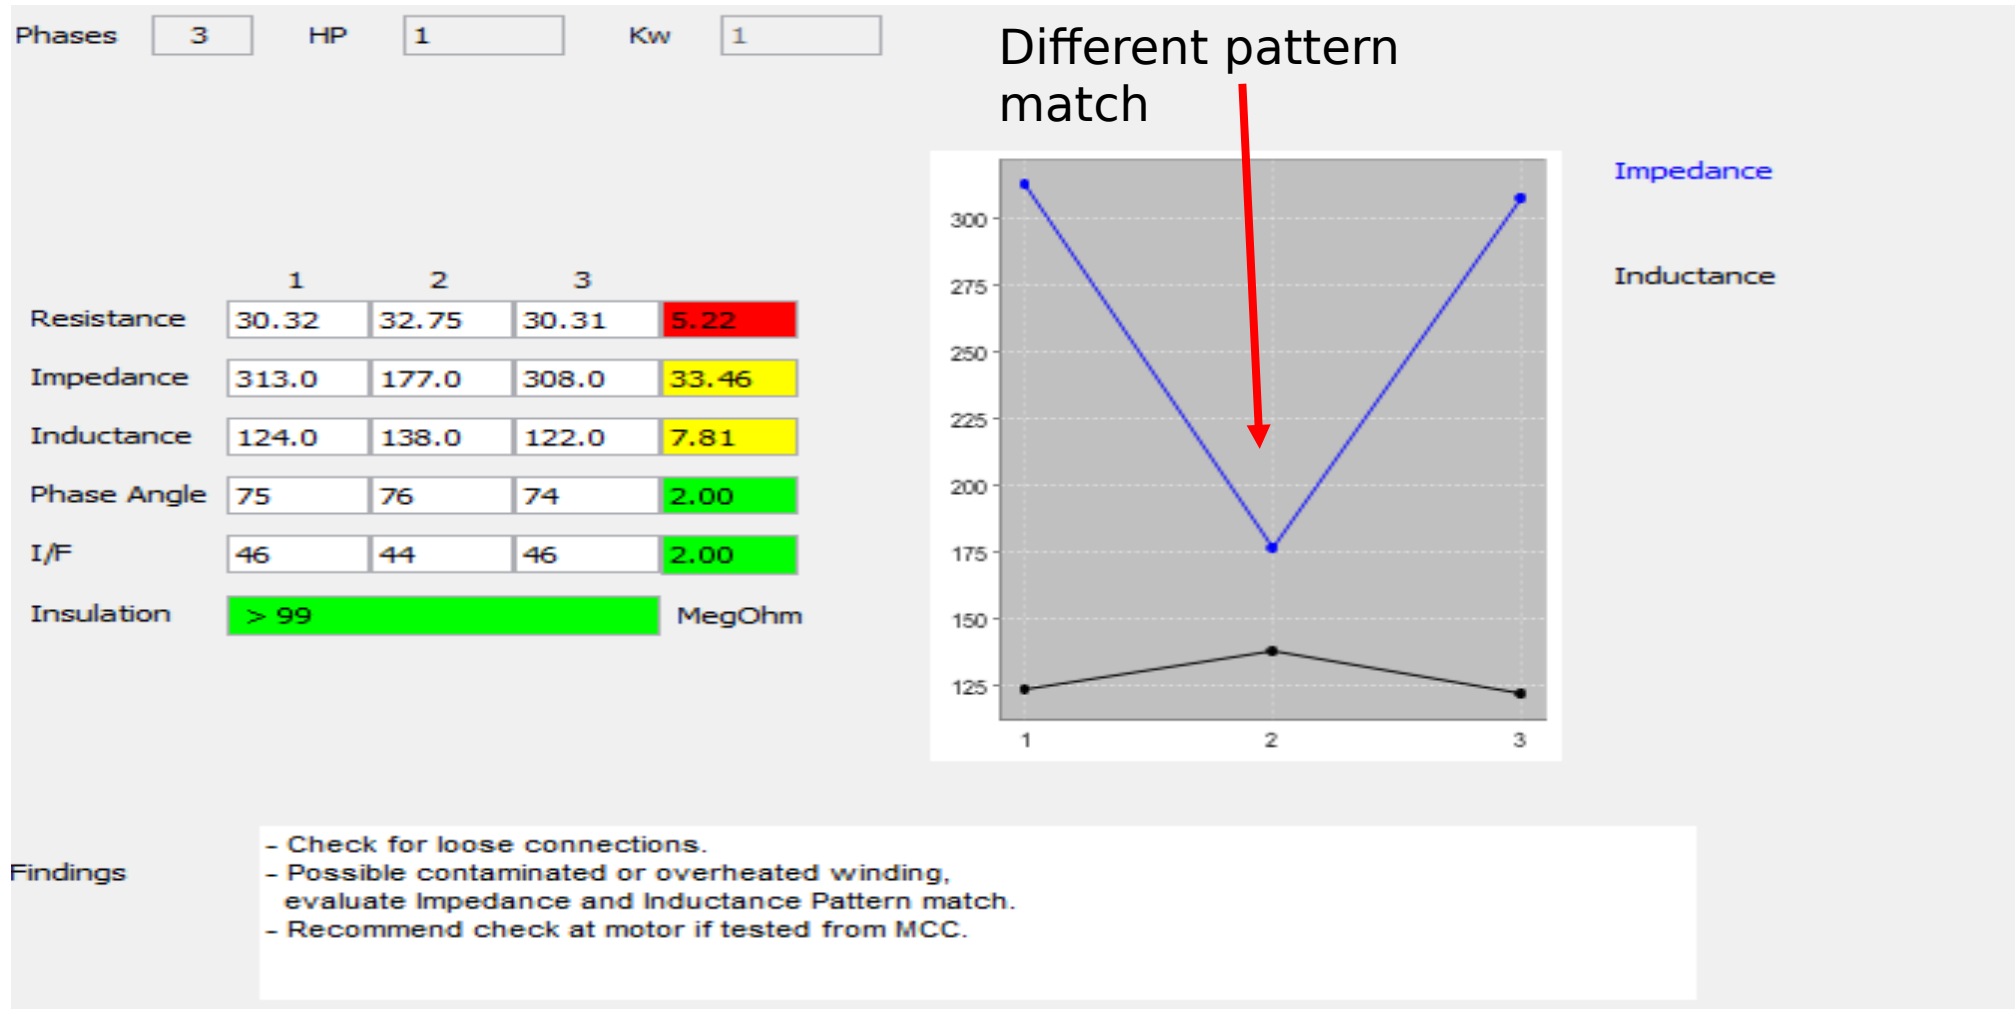
Indication of contaminated or overheated windings using All-test pro 4

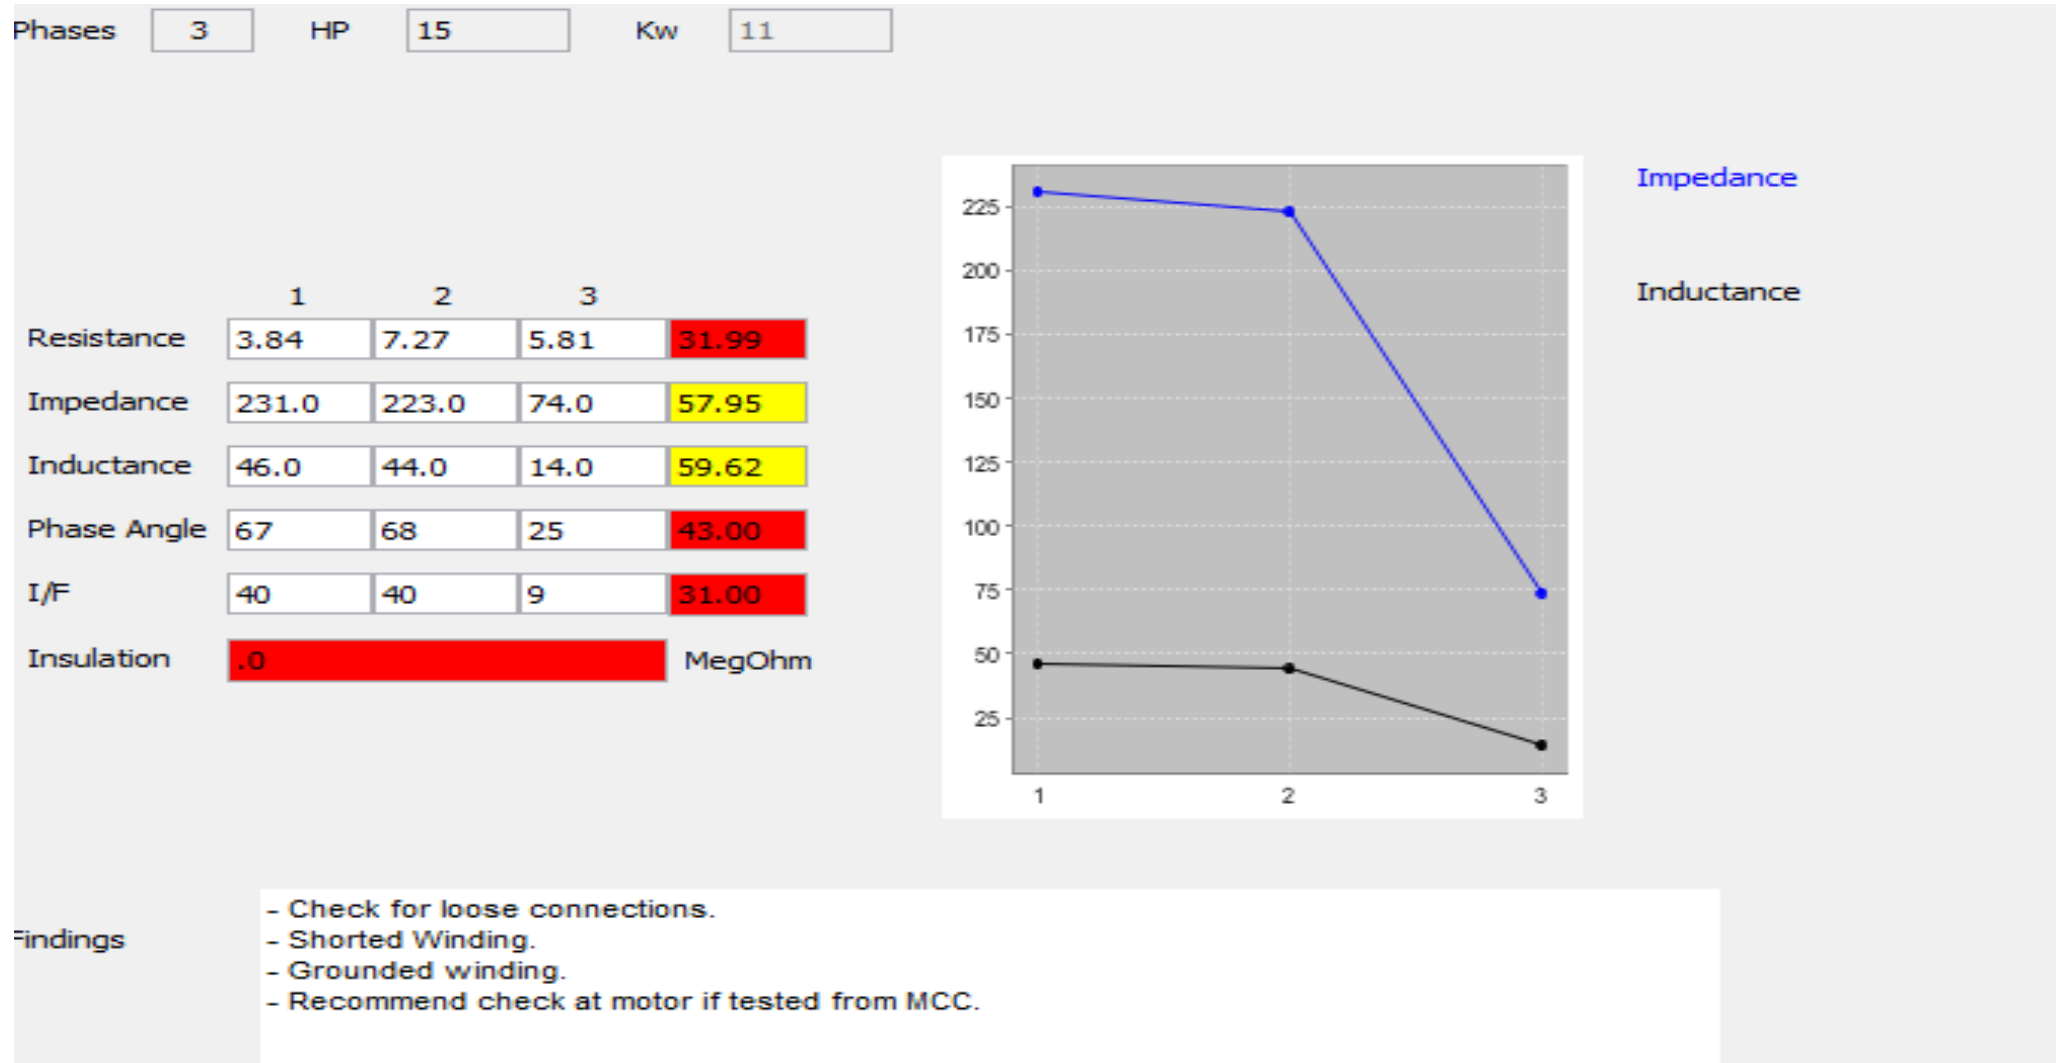
Hydraulic pump motor earth fault with all-test pro 4.

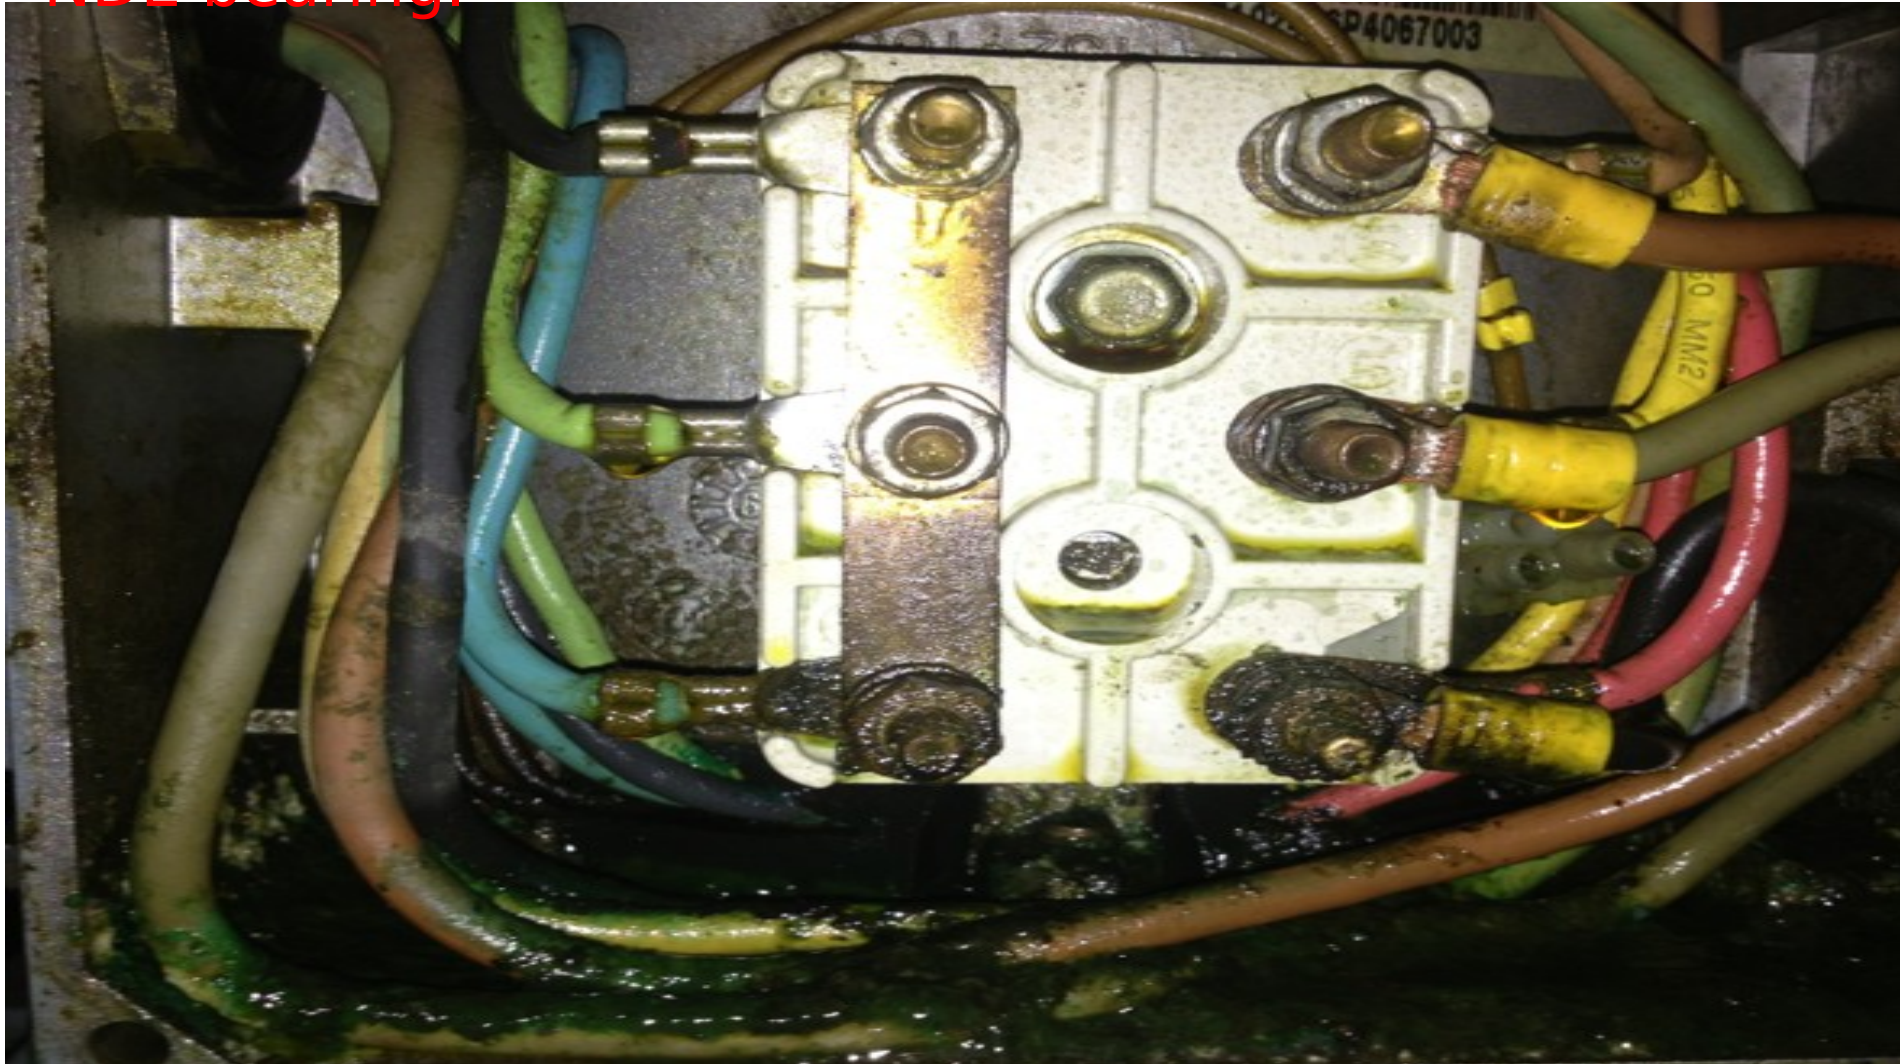
Motor junction box full of watered down grease from NDE bearing.

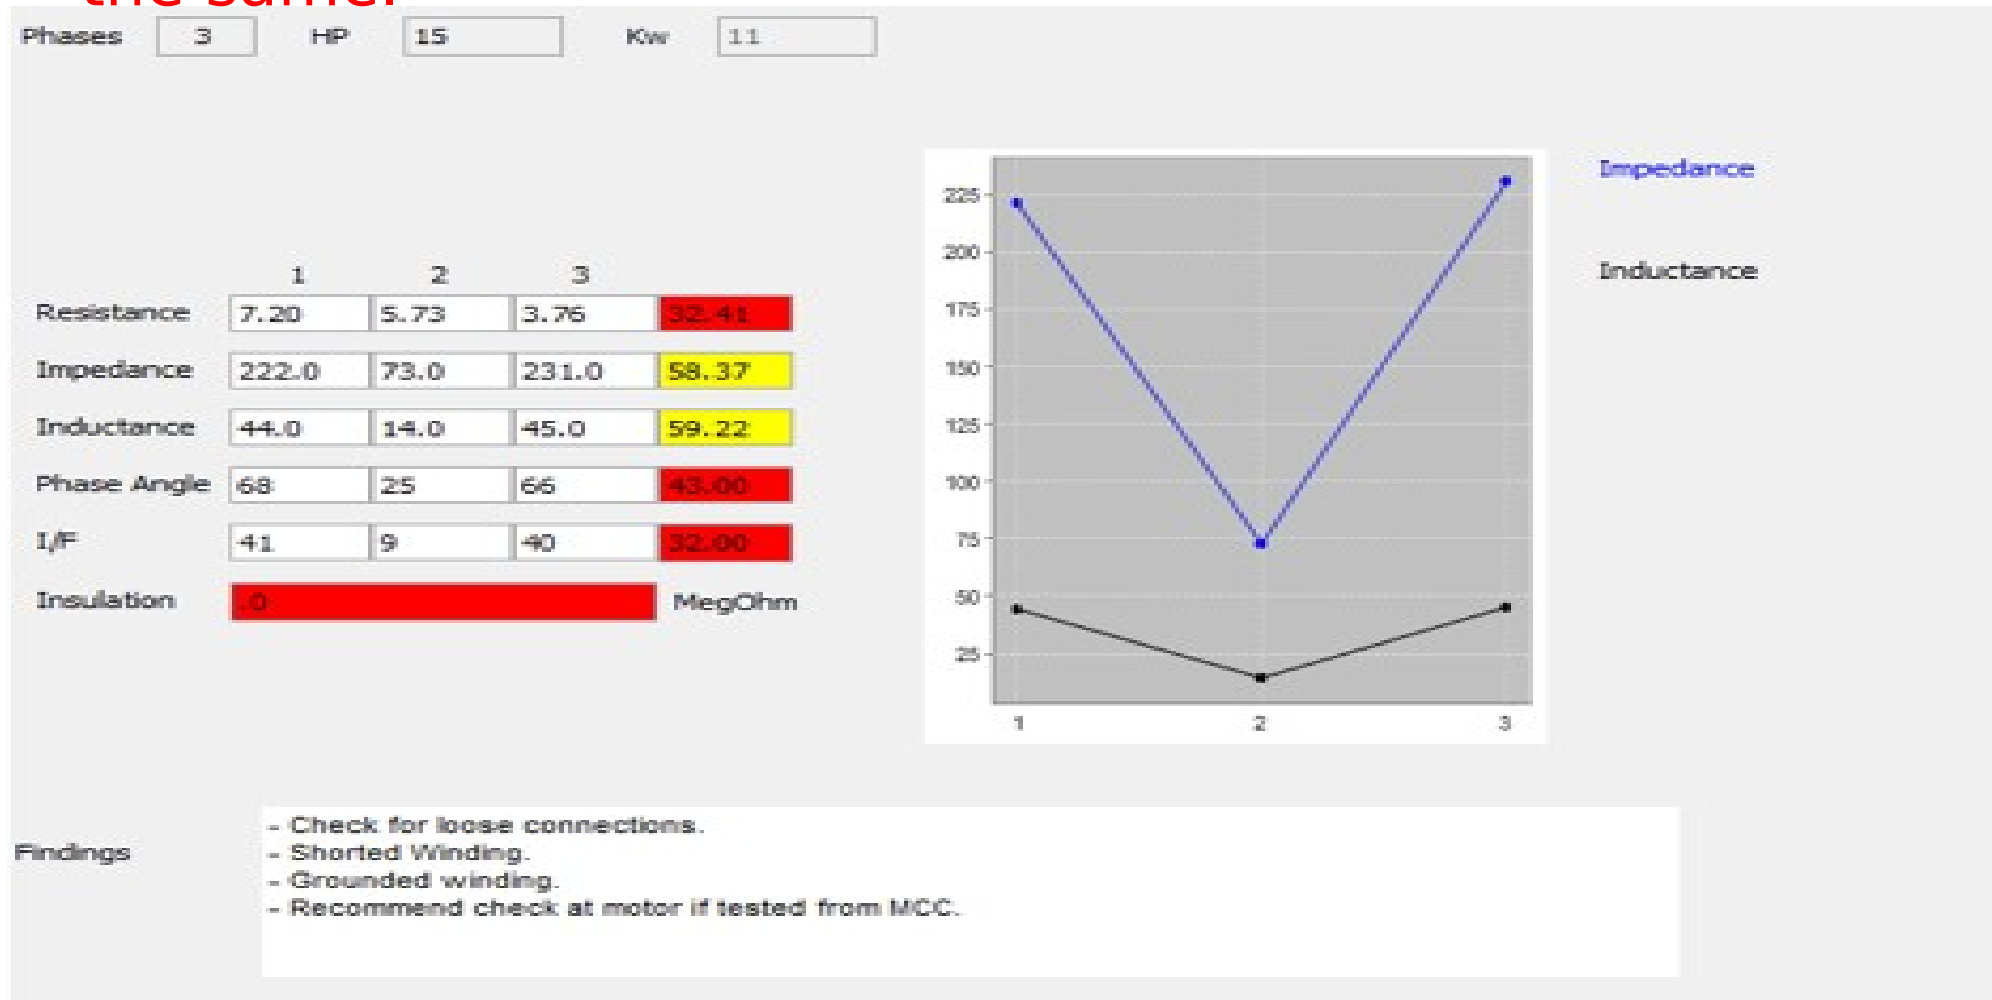
After cleaning out reconnecting motor j/box readings still the same.

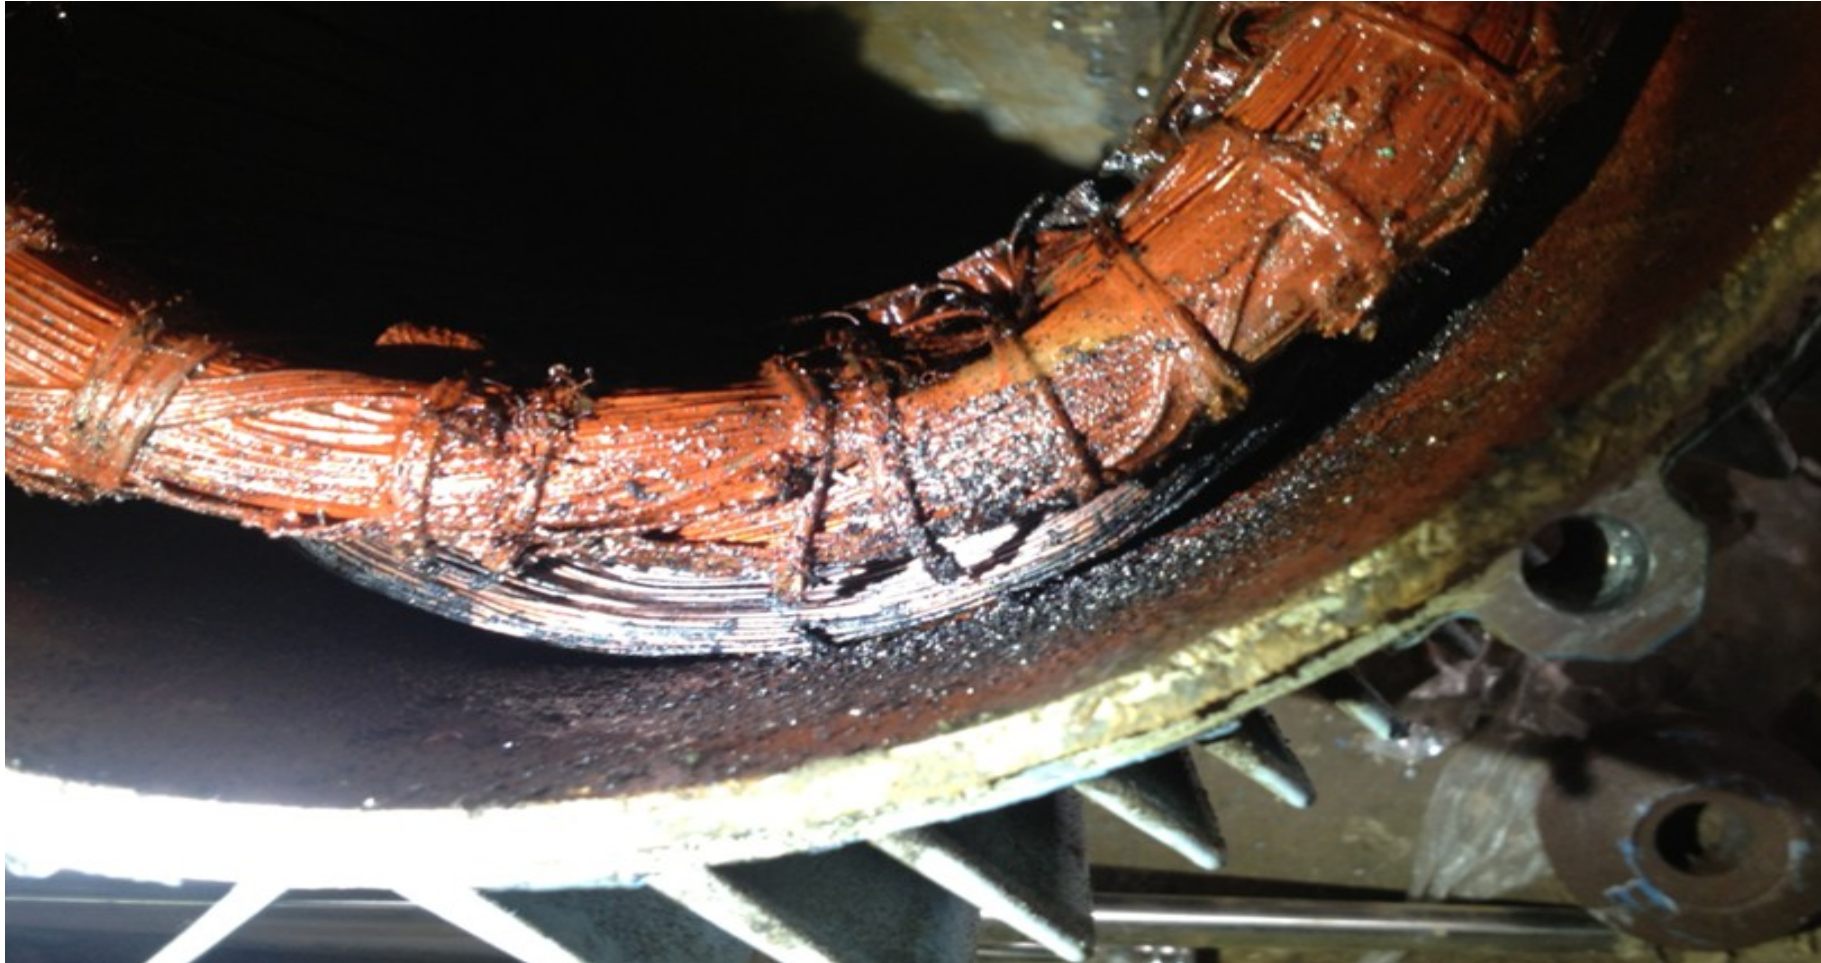
After removing rotor, discovered shorted winding to frame

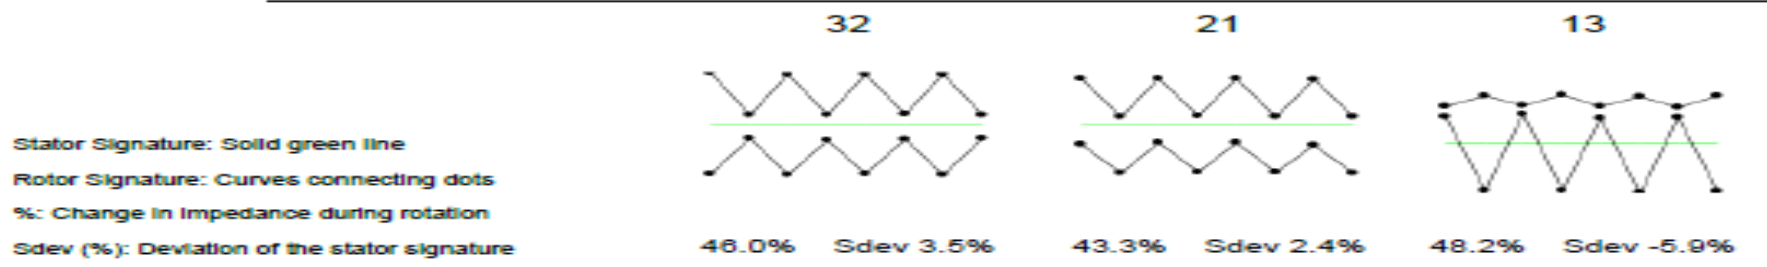
Dynamic test indicating both rotor and stator issues

Green lines do not line up indicating stator issue. Winding 13 dotted line crosses over stator line indicating rotor issues also.

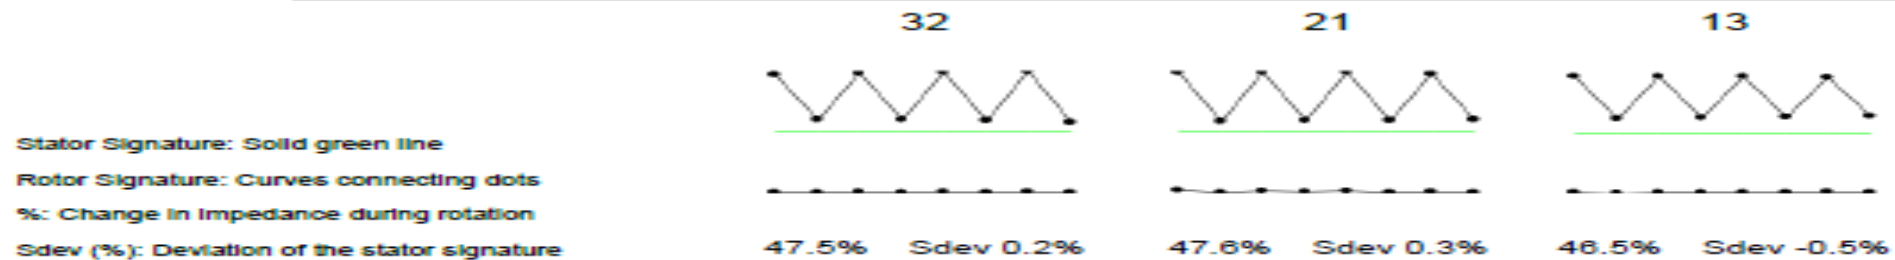
Dynamic tests indicating both rotor and stator are good.

Green lines and dotted lines balanced indicating good stator and rotor.
