## CASE STUDY: 400HP, 1800 RPM, 4000 VOLT MOTOR NO LOAD WITH EMPOWER™

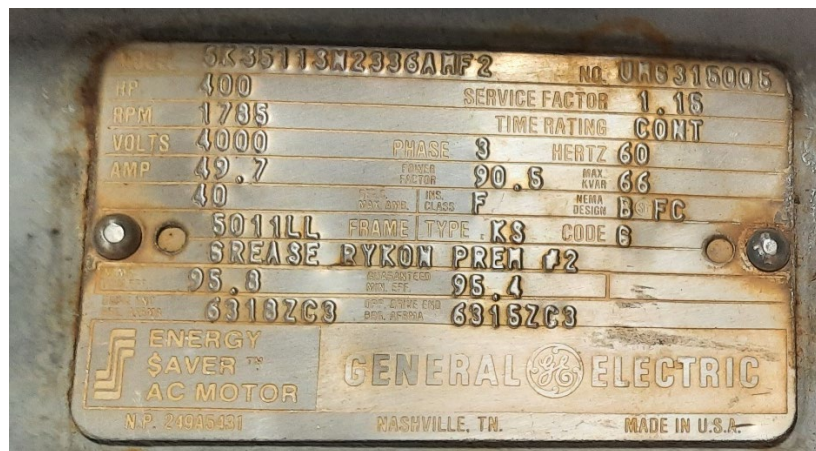
Figure 1: Electric Motor Nameplate

During a training session at a motor repair shop we ran the EMPATH™ and EMPOWER™ systems side-by-side to see what we could observe concerning an electric motor that had just arrived from a repair customer. The motor was a GE, 400 hp, 1785 RPM, 4000 volt motor with 6318 and 6315 bearings (Figure 1). As with all of our repair shop users – they know that the EMPATH and EMPOWER systems have the resolution necessary to test motors at no load, uncoupled and full voltage. There was no notification from the customer as to the reason for the repair.

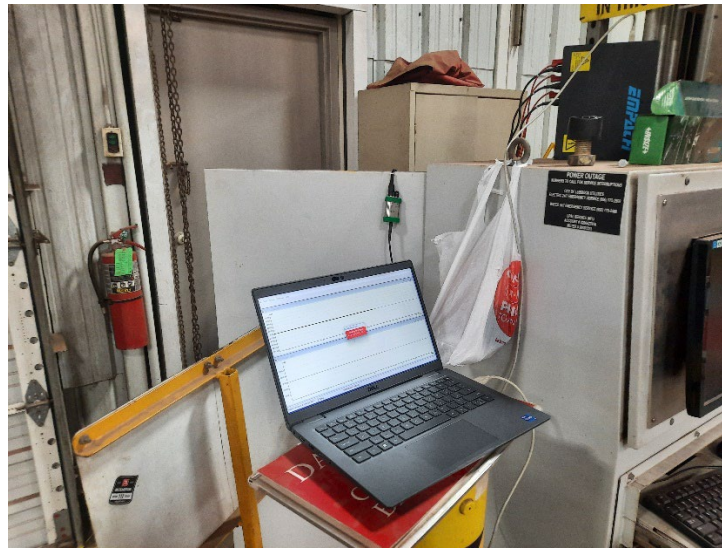
Figure 3: EMPATH data collection upper right and laptop with the EMPOWER hanging over the door of the back of the test panel controls.

Data collection with the EMPATH ESA system took about 48 seconds to collect three phases of voltage and current from the CTs and PTs at the back of the test panel then another 10 seconds to analyze the data using a 12 kHz sample rate. The EMPOWER MCSA system, while having a slightly greater resolution across the 5 kHz (300,000 CPM) spectrum of >0.009 Hz, takes 120 seconds to collect data and another 120 seconds to run special prognostic algorithms for speed, energy with current only, emissions and driven equipment with a 44.1 kHz, 24 bit sample rate.

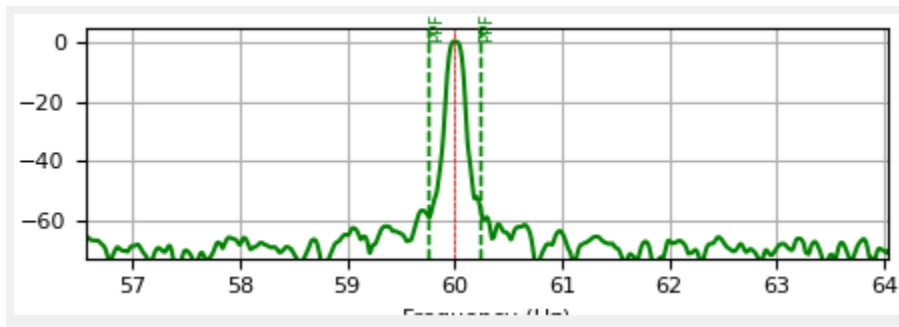
Figure 5: PPF on the unloaded motor at full voltage and uncoupled. Data collected through a 225:1 current transformer.

In Figure 5 you can see the PPF lines fall on small peaks on either side of line frequency. This would indicate the potential for high resistance rings if this is a copper rotor bar or casting voids in a cast aluminum or copper rotor.

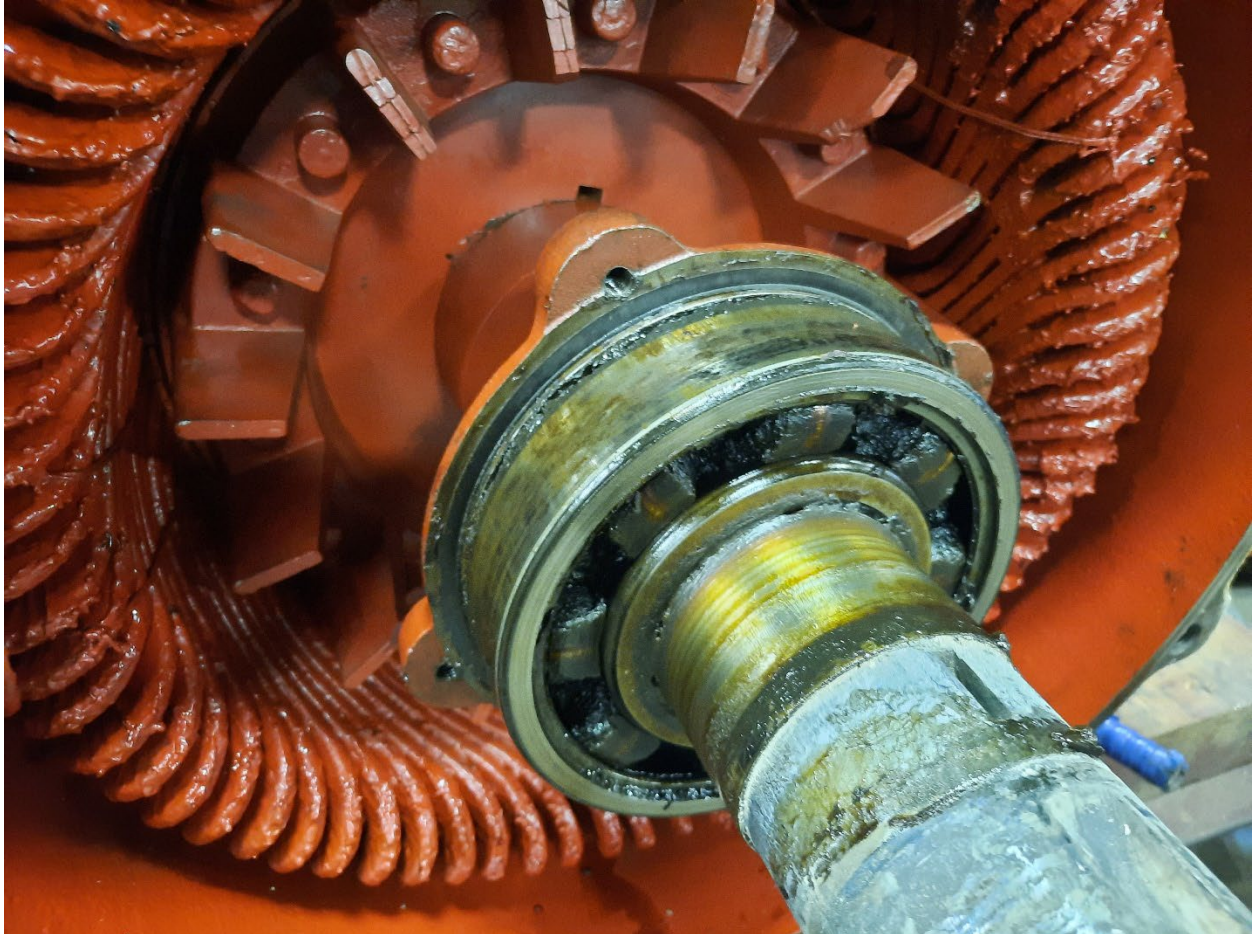
*Figure 7: Drive end bearing and rotor once the end shield was removed.*

As can be seen in Figure 7, the grease is caked in the drive end bearing and the rotor is a cast aluminum. There is also some wear appearing on the outside of the bearing race. At the bottom of the image under the bearing is oil, as the oil separated from the grease. Figure 8 is of the opposite drive end bearing indicating similar findings.
