CASE STUDY:

Municipal Utility District Prevents Motor Failure and Avoids Down Time by Testing Motors Prior to Receipt and Installation

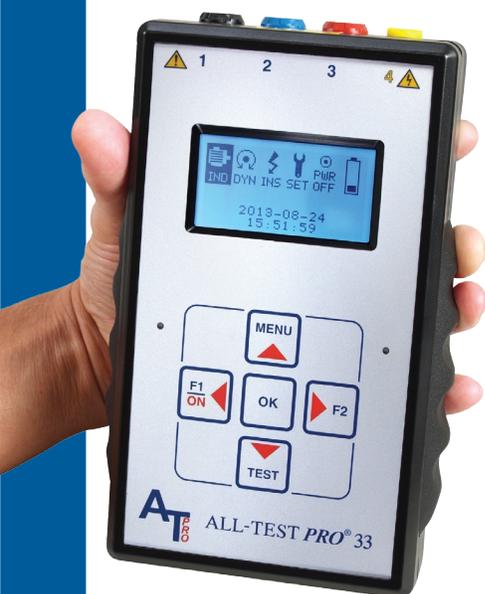
Each pump system (pump, motor, and drive) had been mounted on individual skids. Hogue brought this hand-held ALL-TEST PRO 33 IND™ to the pump suppliers' warehouse to check the condition of the new motors before they could be officially accepted by the MUD. The AT33IND™, which is used for de-energized Motor Circuit Analysis (MCA™), is specifically designed for troubleshooting motors and commissioning new and rebuilt motors before installation. The AT33IND™ enables the operator to identify motor conditions that include winding contamination, stator and rotor unbalance, changes in rotor and stator condition, resistance in windings, contamination, and insulation to ground issues.

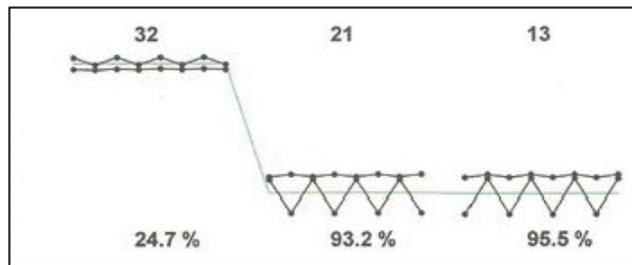
Hogue connected the AT33IND™ to the motor box leads and performed a static and dynamic tests. He generated reports for each of the motors, with one report showing test results consistent with a developing winding fault in Phase 3-2.

Resistance	✓ OK	83.87 mohm	84.10 mohm	84.27 mohm
Stator	✗ Bad	Reference value 33.62 Test value 33.62 (dev 0.00%)		
Rotor	✓ OK			
Contamination	✓ OK	1.23 %	25.61 nF	
Insulation	✓ OK	936 Mohm

Hogue discussed the test results with the MUD, explaining why his acceptance report showed one motor should not be accepted, approved for installation. Even though the motor was brand new, the AT33IND™ showed a defect and provided an alert to the potential of a motor failure. The MUD requested the questionable motor be returned to the vendor and replaced with another unit. A new motor was delivered a week later, and Hogue returned to the pump suppliers' warehouse with his AT33IND™ hand-held testing instrument to test the replacement motor. This time, the new motor passed the acceptance test.
