CASE STUDY:

Off shore Oil Rig Protects its People and Equipment Using the ALL-TEST PRO 5™

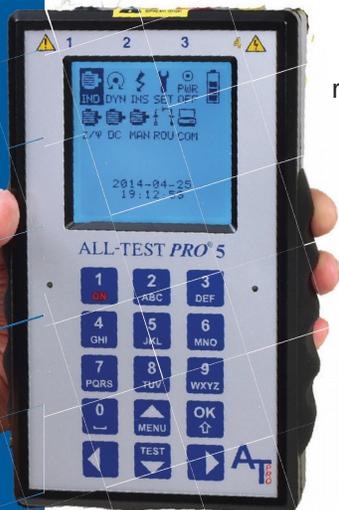
Test Results for the Crane Motor

20150918-14:30:56						
		32	21	13		
Resistance (Ohm)	OK	0.014	0.014	0.015	1.03	
Impedance (Ohm)		6.78	8.43	8.13	12.9	
Inductance (mH)		2.70	3.35	3.24	12.9	
Phase Angle (°)	OK	82.3	81.6	81.8	0.402	
I/F (%)	OK	-44.8	-44.6	-44.6	0.139	
Stator						
Rotor						
Insulation (MOhm)	OK	>999		Test Value	6.59	Ref Value
Contamination (%)						
Capacitance (nF)	OK	1.84%		Frequency	400	Direct Test at Motor

The results of the motor testing showed the following: DC winding resistances were all well balanced; Winding AC Impedance were following the Inductance; Phase Angle and I/F% test results were all well balanced; "Stator" & "Rotor" result rows are empty because a dynamic test had not been performed on the 1000-hp motor.

Testing revealed that the windings and connections for this 3-phase motor were in good condition. A static test was performed using the AT5™ for this 1000-hp motor, which includes testing between the motor winding phases. Phase to phase measurements were then compared and simple rules were used to determine the condition of the motor connections and windings. Additionally, the insulation to ground test and dissipation factor test were used to evaluate the condition between phase and ground.

If the test results show some variation between the windings, it is a sign there is a problem with the motor. In this case, the test results showed that all three windings were in the same condition; therefore, the technician was able to conclude that the motor was healthy.
