CASE STUDY:

Predictive Maintenance Team Saves Steel Mill Time and Money with Thorough Motor Testing

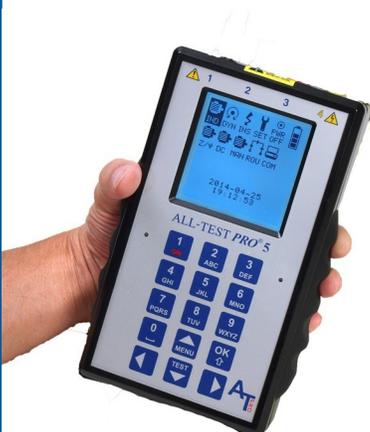
The AT5™ was connected to the motor control panel and a Motor Circuit Analysis™ was performed on the 20-horsepower trolley motor. Within only a few minutes time, the test results showed a disconcerting insulation-to-ground readout of 10.Meg-Ohms (see figure 1)

32	21	13	
Resistance (Ohm)	OK	0.840	0.836	0.831	0.580
Impedance (ohm)		11.1	11.2	11.2	0.876
Inductance (mH)		8.78	8.90	8.90	0.884
Phase Angle (°)	OK	75.6	75.4	75.5	0.0750
I/F (%)	OK	-46.2	-46.0	-46.1	0.0936
Stator					
Rotor					
Insulation (MOhm)	WARN 10.1			TVS	18.6
				Ref Value	
Contamination (%)	NA			Frequency	200
Capacitance (nF)	NA

Figure 1. Results from AT5™ motor testing instrument; from Motor Circuit Analysis™ performed at motor control panel on March 6th, 2017.

This 'practically new' motor, which had been installed onto the crane in October of 2016, was tested at the time of its initial installation. That very first test had shown a reading of greater than >999 Meg- ohms. This difference in test results raised some red flags for the predictive maintenance team. Seeing as how the motor had only been in operation for six months, it was clear that the motor should not have deteriorated that quickly.
