## Electrical Signature Analysis Performed on Vertical Turbine Pump Motors in Municipal Application

Authored by William Kruger, Technical & Training Manager, ALL-TEST Pro, LLC, and Alex Panattoni, Control Systems Technician II, City of Henderson Department of Utility Services Electrical Section

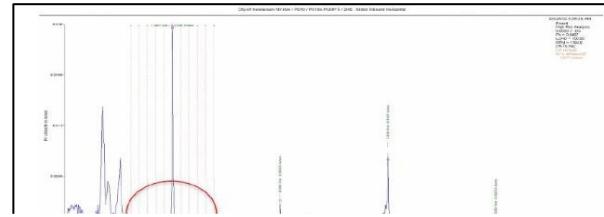
ow- amplitude sideband sets spaced at "pole passing frequency". The red circle highlights the location of calculated pole p
