MOTOR CIRCUIT ANALYSIS TESTING AT WATERSURE USING ALLTEST PRO 5 ANALYSER.

- TO UNDERSTAND TRUE CONDITION OF PLANT CRITICAL MOTORS.
- TO REPLACE/OVERHAUL MOTORS BEFORE CATASTROPHIC FAILURE OCCURS.
- TO HELP ENSURE MOTOR AND PLANT RELIABILITY INTO THE FUTURE AT WATERSURE.

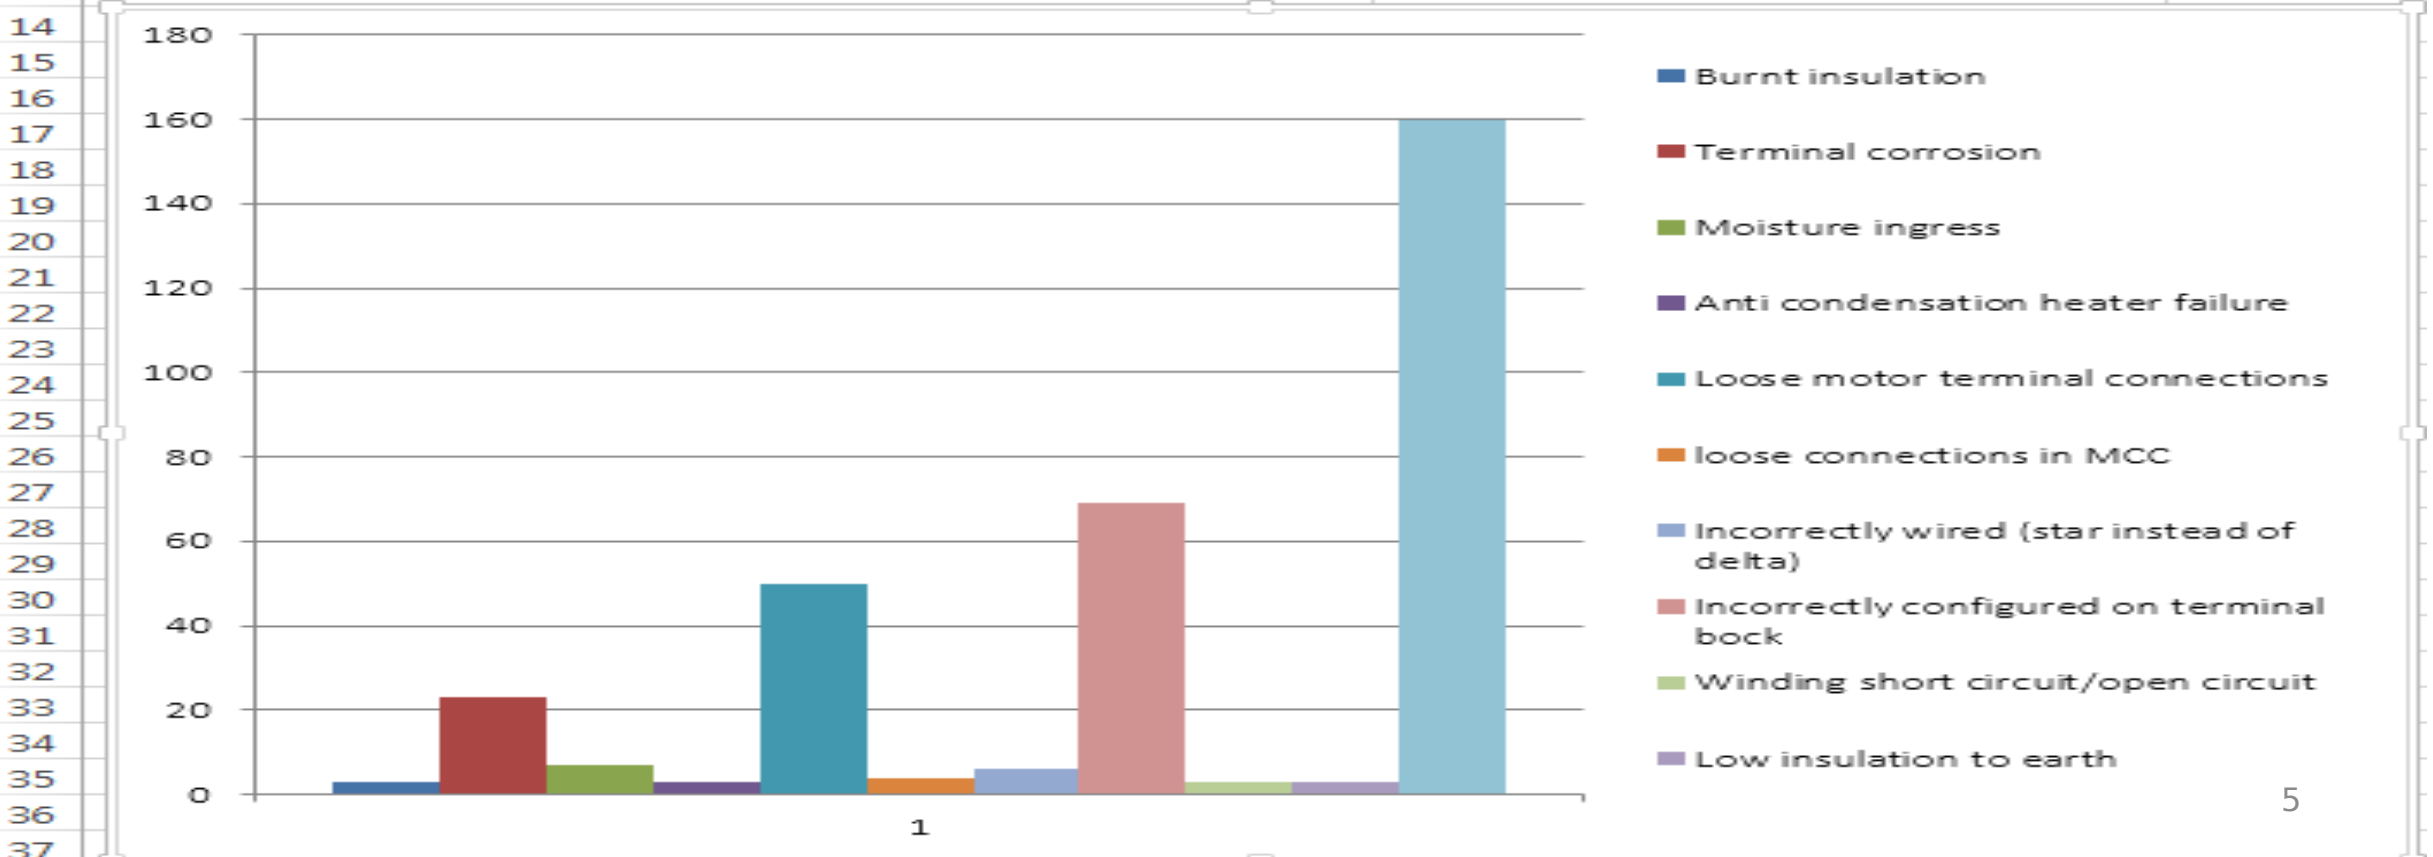
STATION:

Motor circuit analysis, testing and findings	Number of motors tested
Burnt insulation	3
Terminal corrosion	23
Moisture ingress	7
Anti condensation heater failure	3
Loose motor terminal connections	50
loose connections in MCC	4
Incorrectly wired (star instead of delta)	6
Incorrectly configured on terminal bock	69
Winding short circuit/open circuit	3
Low insulation to earth	3
Motor good condition and no issues	160

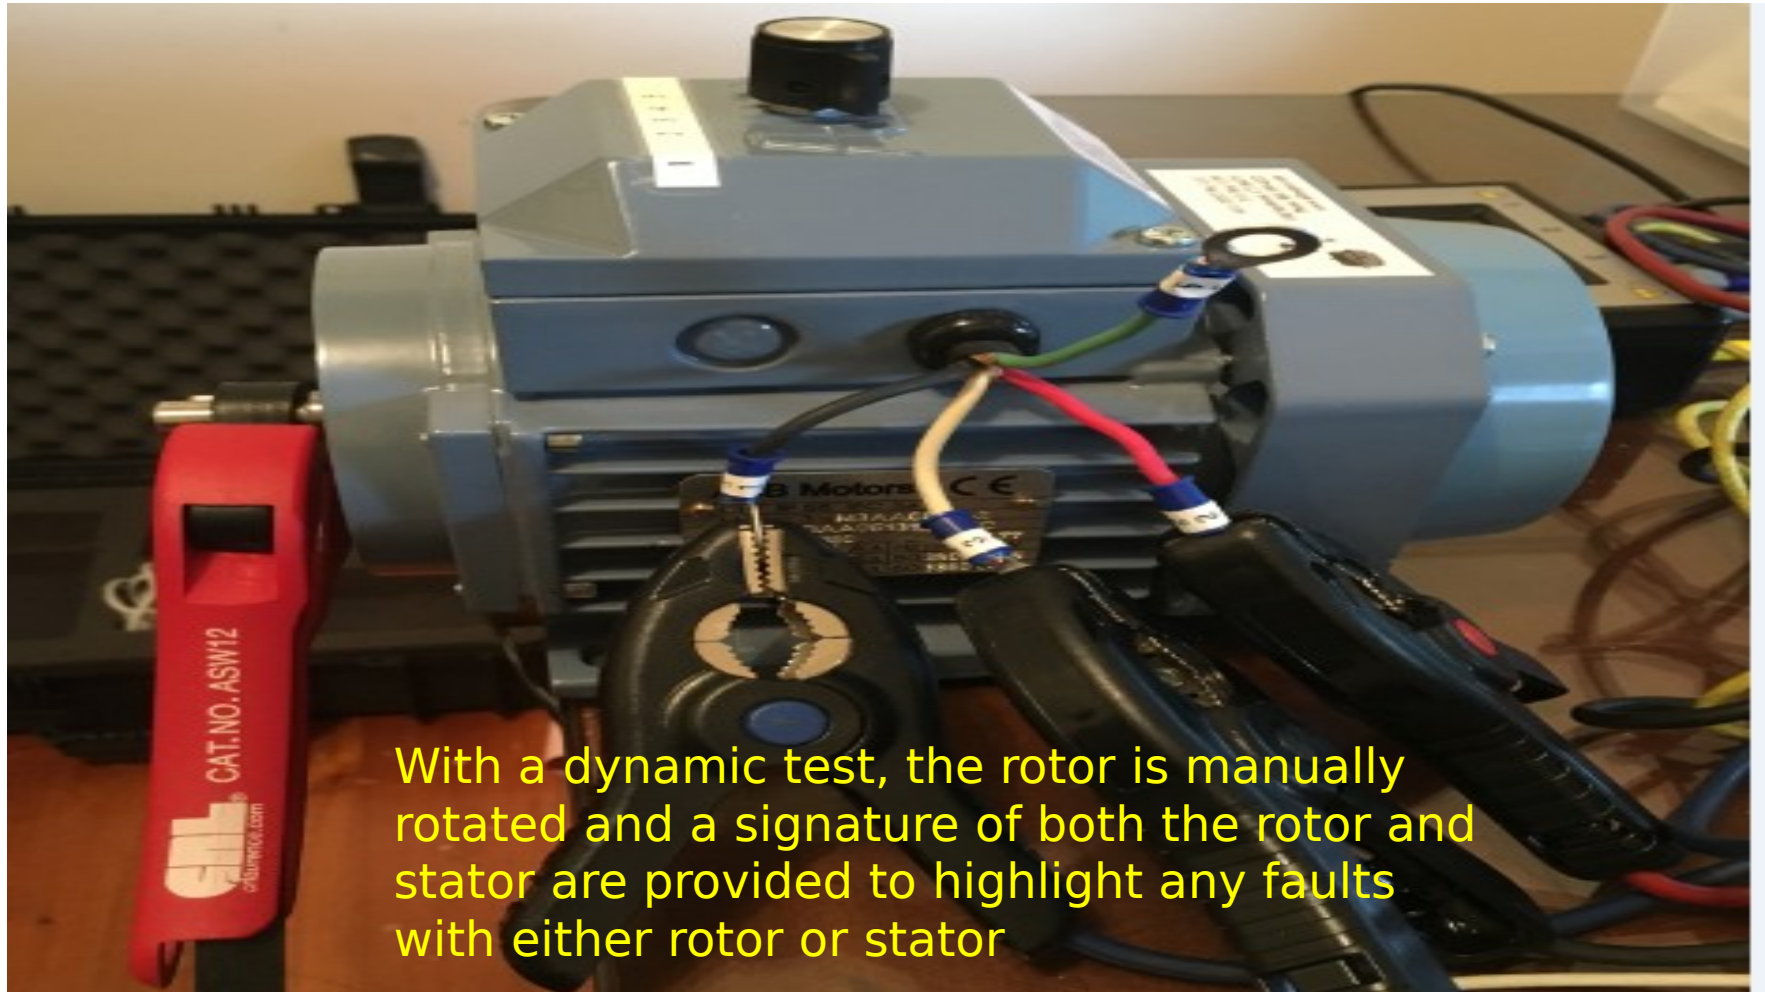
With a dynamic test, the rotor is manually rotated and a signature of both the rotor and stator are provided to highlight any faults with either rotor or stator

Dynamic test indicating both rotor and stator issues

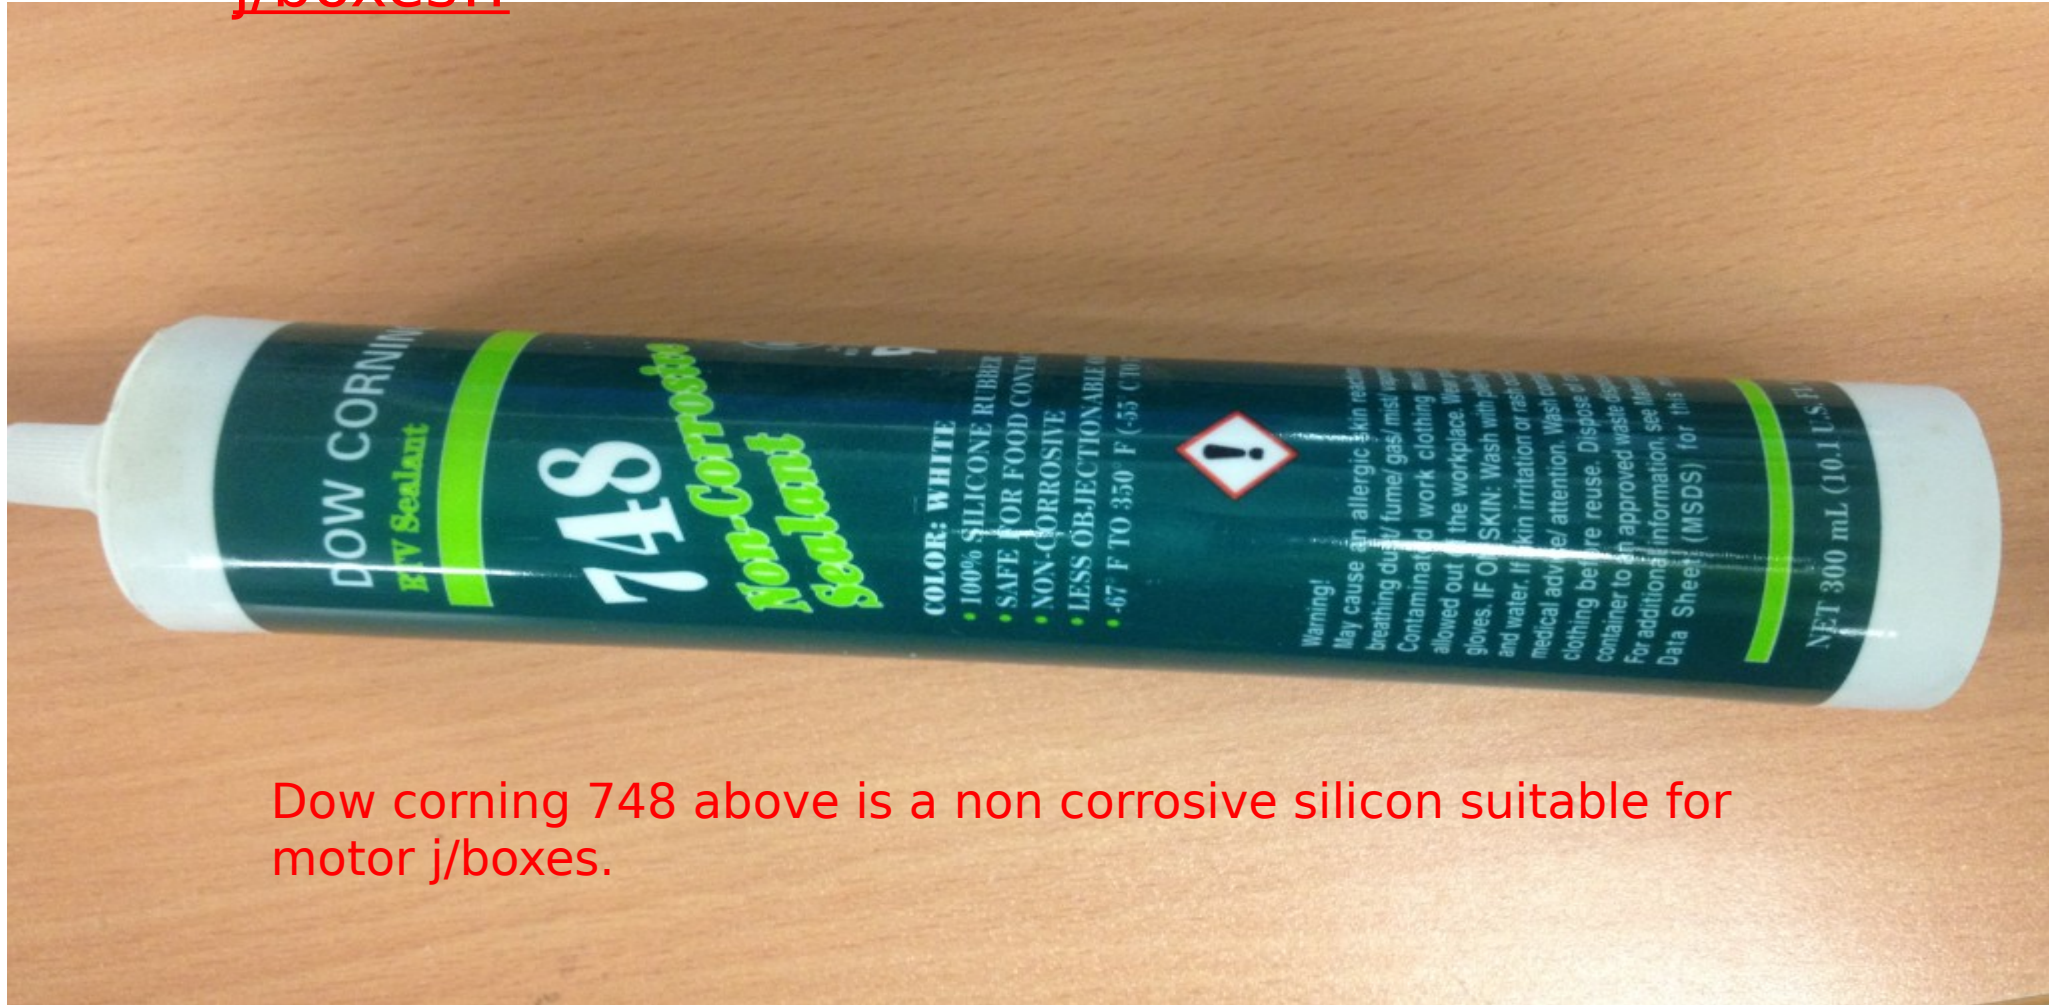
Dow corning 748 above is a non corrosive silicon suitable for motor j/boxes.

Typical silicon contains acetic acid and is very corrosive to motor connections!!

Ensure only non acetic silicon is utilized on motor j/boxes!!
