CASE STUDY:

What is 3 Minutes of Motor Testing Worth to You?

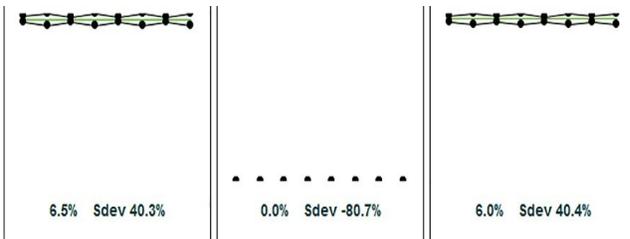
Using the AT5™, connections were made to the three phases of the motor and a static test was performed. Next, the motor shaft was manually moved during the dynamic portion of the 3-phase test, and at the end of the test the instrument showed the results (as shown on the right).

When performing the dynamic test between phases 2-1, it became clear that this was the phase that had the problem.
